# **Gunstock Brook Watershed Stream Geomorphic Assessment**

**Gilford, New Hampshire  
July 9, 2012**

Prepared by:  
Bear Creek Environmental, LLC  
297 East Bear Swamp Road  
Middlesex, Vermont 05602

Prepared under contract to:  
Belknap County Conservation District  
2 Airport Road, Unit #1  
Gilford, NH 03249

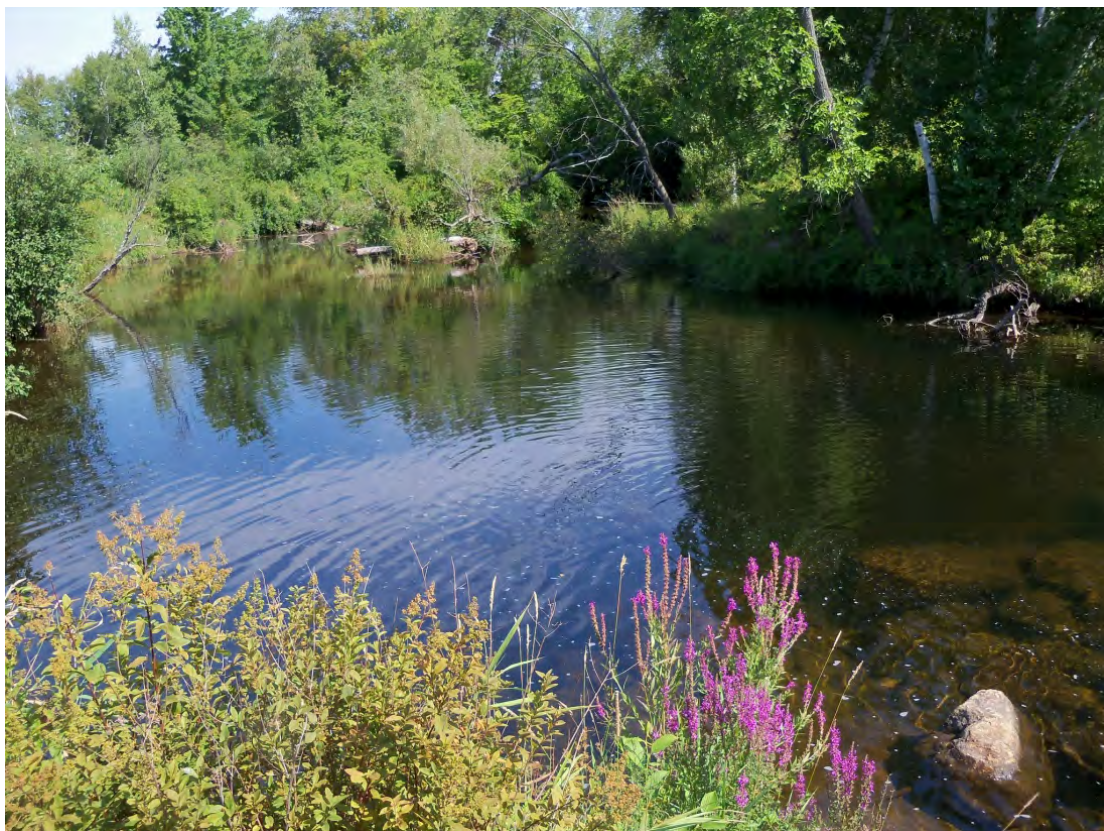
**Figure 8.1. Impounded segment M01-A**

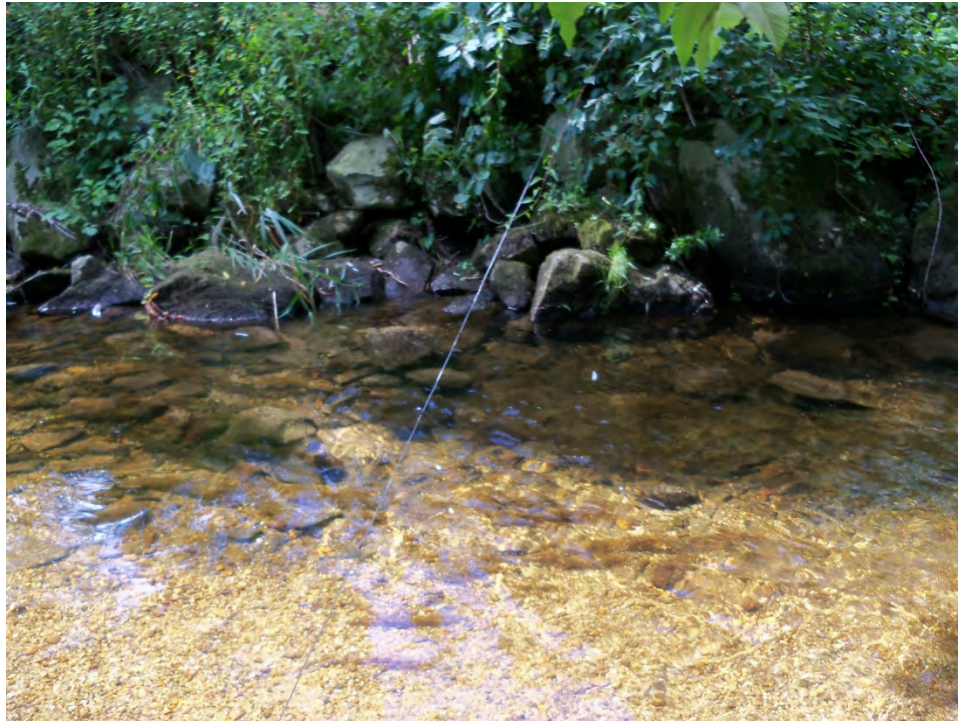
Segment M01-B begins just upstream of the Lakeshore Road crossing and continues upstream for 1,200 feet until Old Lakeshore Road. Extreme degradation has occurred in this segment due to the extensive channel alteration, which has resulted in a stream type departure from a “C” stream to a “B” stream. Widening is being prevented by the abundant riprap (Figure 8.2). Riprap is graded rock that is used to stabilize banks. The bedform has been altered from riffle-pool to plane bed (i.e. lacks defined habitat features) due to the channel alterations. The geomorphic and habitat condition of Segment M01-B are both “fair”. The lack of large woody debris, embedded channel, lack of riffle habitat, and the lack of vegetation on both banks and in buffers has led to the “fair” habitat condition.

**Figure 8.2 Rock riprap in vicinity of measured cross section in M01-B.**

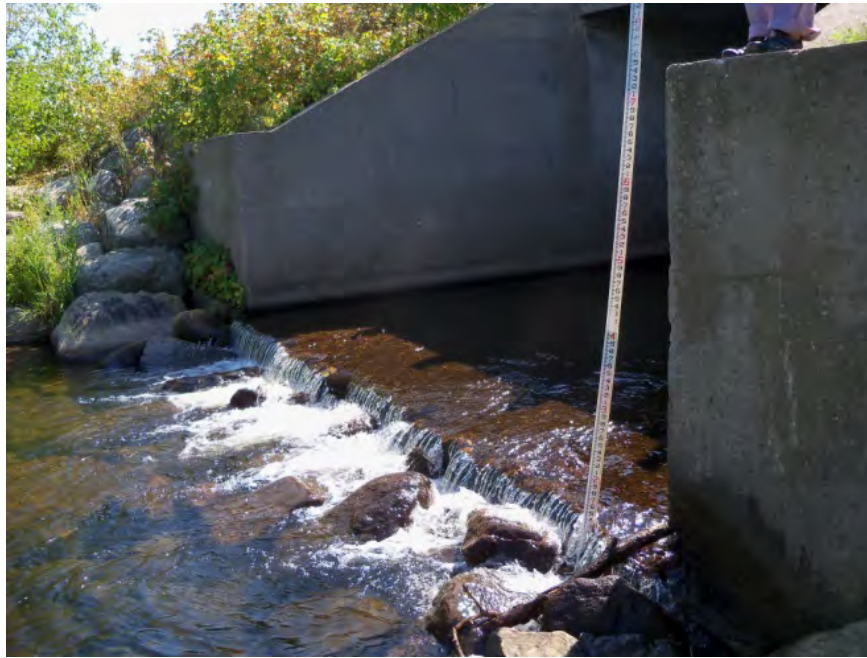
**Figure 8.3. Perched box culvert at Lakeshore Road.**

Three potential projects have been identified by BCE in segment M01-B based on the Phase 2 study. The first project is the retrofit or replacement of a box culvert at the Lakeshore Road crossing, which is impeding fish passage (Project #1, Figure 8.3). Based on the Vermont AOP culvert screening tool, the AOP retrofit potential is medium for strong and moderate swimmers and low for weak swimmers. Additional studies are recommended to determine if the replacement or retrofit of the culvert makes more sense. Project #2 includes improving stormwater runoff to alleviate excess sediment into the stream (Figure 8.4). The third project involves a bridge at the Old Lakeshore Road crossing at the upstream end of M01-B. The Old Lakeshore Road crossing is in poor condition due to deteriorating decking and pier (Figure 8.5). This structure was placed in the high priority category for replacement. It is recommended that the bridge be replaced (Project #3) and special consideration be given to geomorphic compatibility including the span and alignment as part of the bridge design.

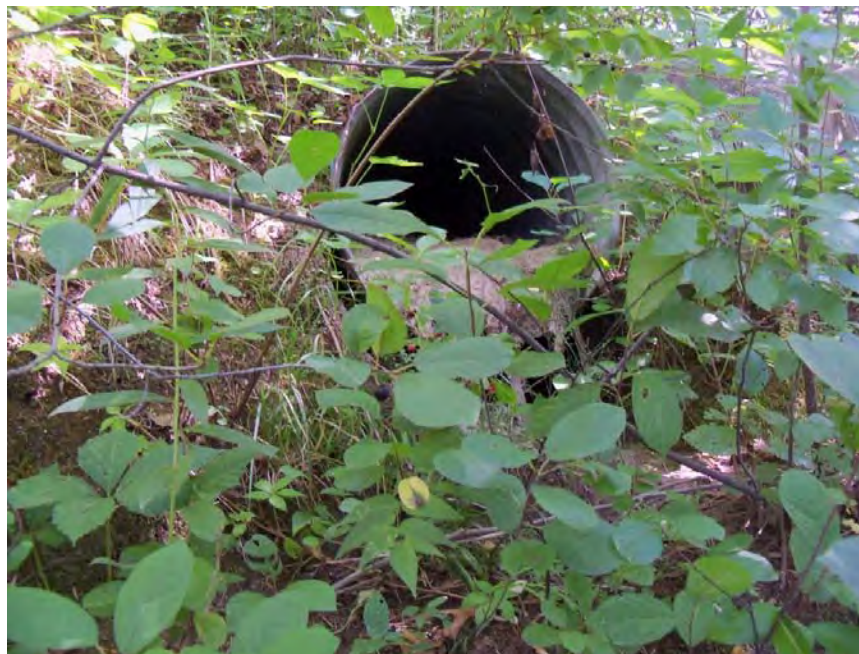
**Figure 8.4 Sediment laden stormwater culvert along segment M01-B.**

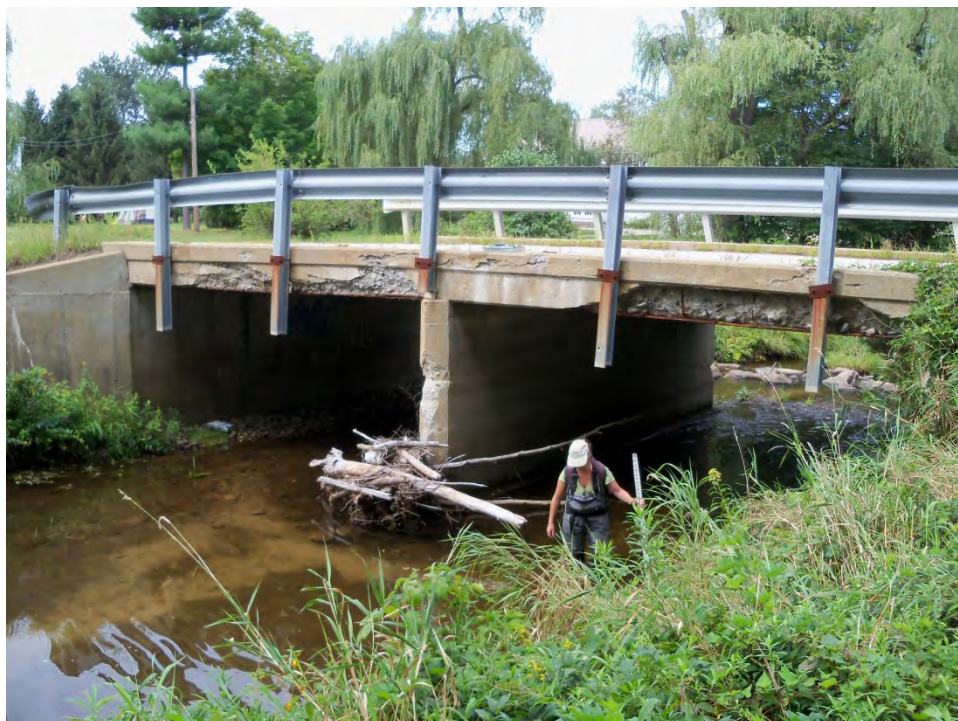
**Figure 8.5. Deteriorating decking and pier of Old Lakeshore Road Bridge in Segment M01-B.**

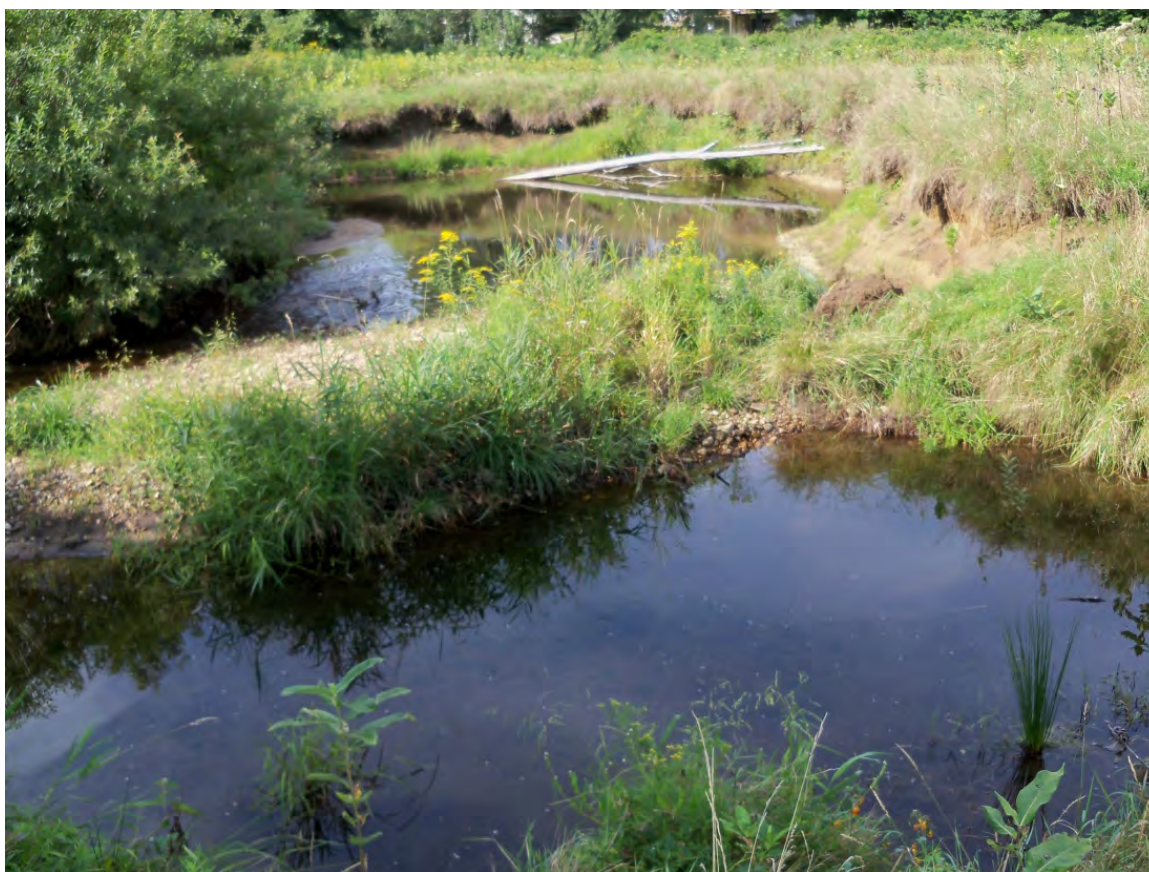
There is a proposed NRCS project (SB4) in segment M01-D project (SB4) that involves streambank stabilization of a bank that is experiencing significant erosion (Figure 8.6). The river is currently in an adjustment process that will move it towards a stable or equilibrium condition through erosion and deposition of sediment. If allowed to continue in the current course, the river will eventually create a bankfull bench or floodplain at a lower elevation. It is understandable that the farmer is concerned about losing land in this location. If the farmer is amenable, a wide buffer of land could be taken out of production and the farmer could be compensated for this additional land through the CREP program. Problems associated with riprapping this section include loss of aquatic habitat, increased energy and erosion downstream of the riprapped section and loss of floodplain access. If the landowner and NRCS decide to move forward with riprapping the bank, a biotechnical approach is recommended. A biotechnical approach may include grading the upper bank and planting with trees as well as incorporating live cuttings such as willow into the rock toe.

**Figure 8.6. Bank erosion (looking upstream) along Segment M01-D at proposed NRCS project SB4**

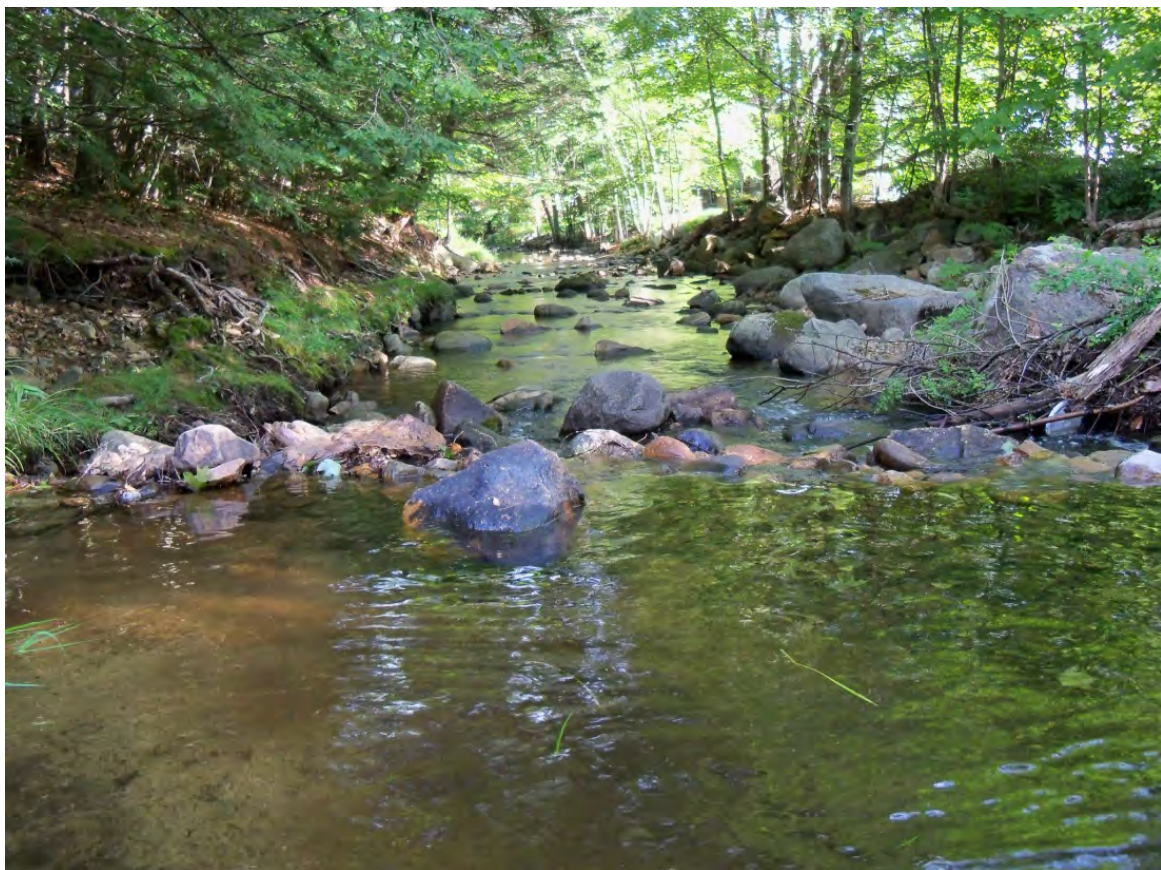
Development within the river corridor is pronounced in segment M01-E. Approximately 30 percent of segment M01-E has been straightened and armored, which has led to major degradation of the stream channel. The extensive armoring is seen just downstream of Henderson Road on the east bank (Figure 8.7). The incision process has resulted in a loss

**Figure 8.7. Segment M01-E just downstream of Henderson Road crossing with abundant riprap on east bank.**

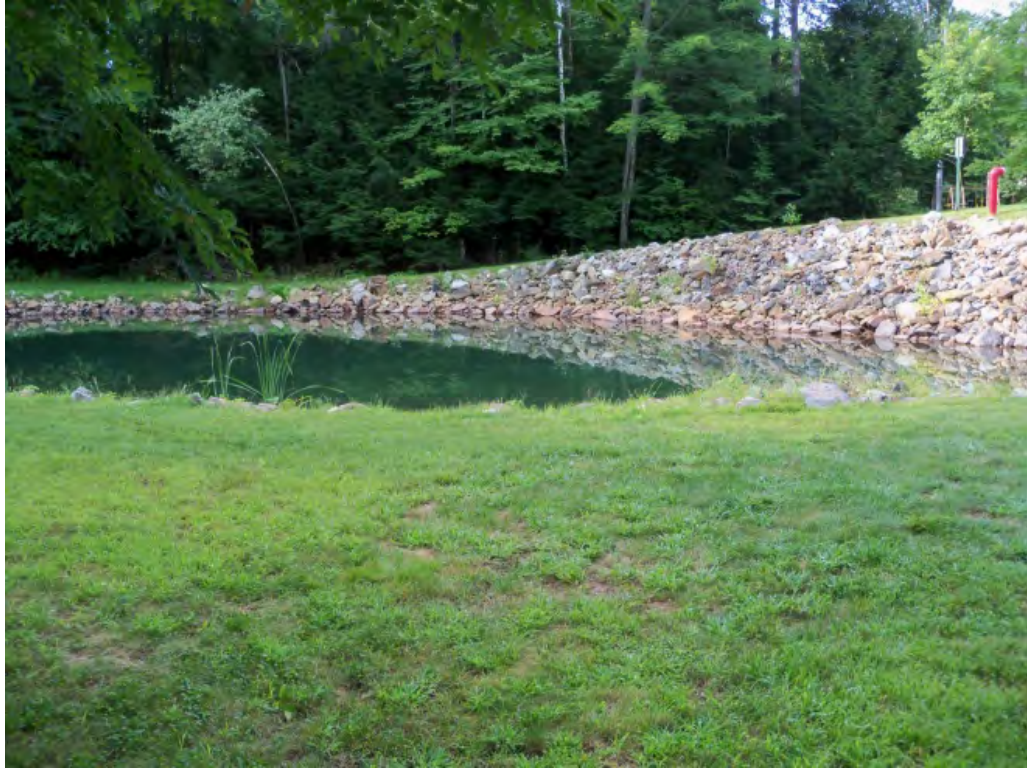
In the center of M01-E, there is a stormwater retention pond in the western side of the river corridor (Figure 8.8). The retention pond is helping to alleviate the impact of stormwater drainage from the nearby development into Gunstock Brook. However, the buffer vegetation within the vicinity of the stormwater pond is predominantly herbaceous, which does not provide the best riparian condition. Approximately 180 feet downstream of the pond is another stormwater input that is causing localized erosion on the western stream bank, which is contributing sediment to the channel (Figure 8.9). It is recommended that the stormwater runoff in this location be improved to alleviate further sediment contribution to the channel (Project #4).

**Figure 8.8. Stormwater Pond in the river corridor for M01-E.**

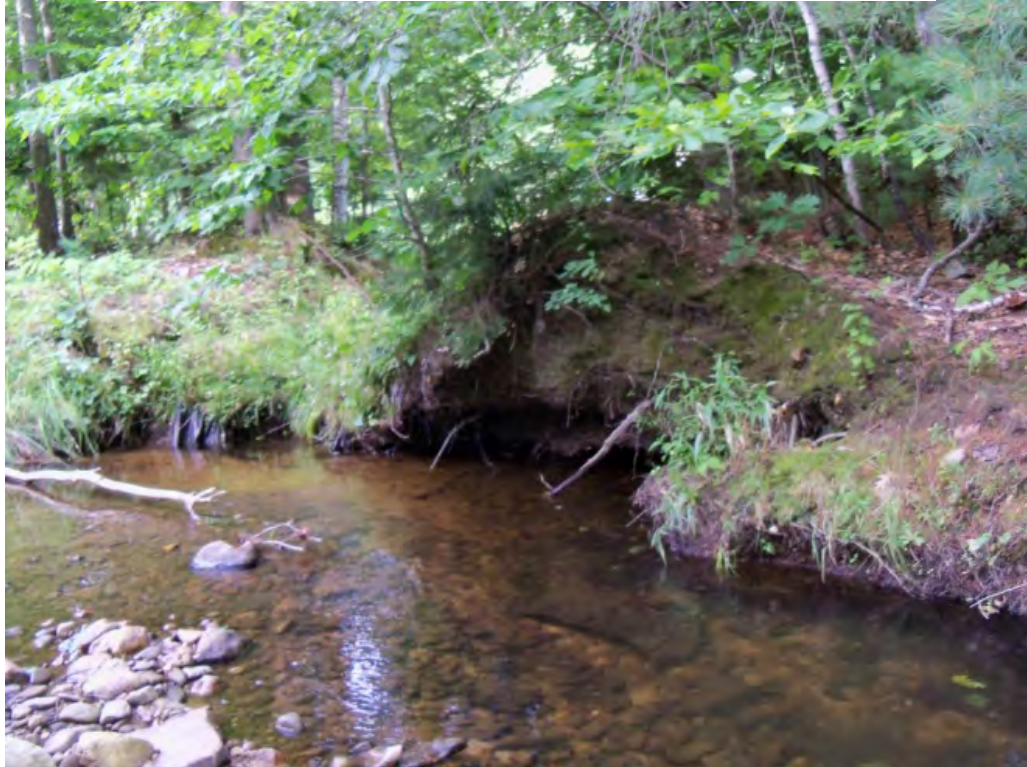
**Figure 8.9. Stormwater input causing localized erosion on streambank in M01-E.**

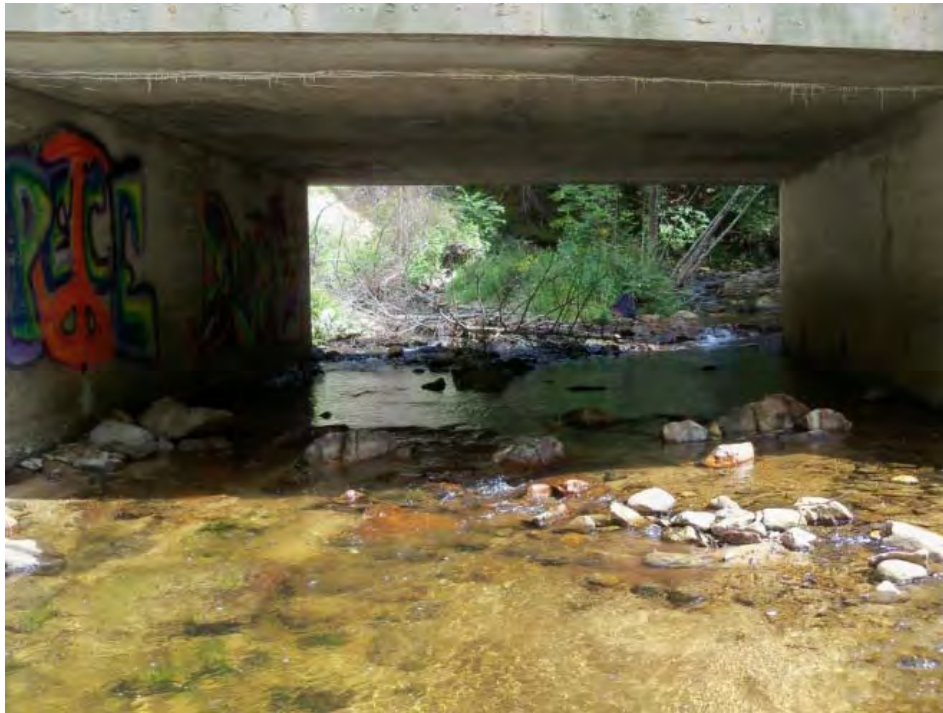
**Figure 8.10. Undersized and misaligned Intervale Road Bridge with mid-channel bar upstream in M02-A.**

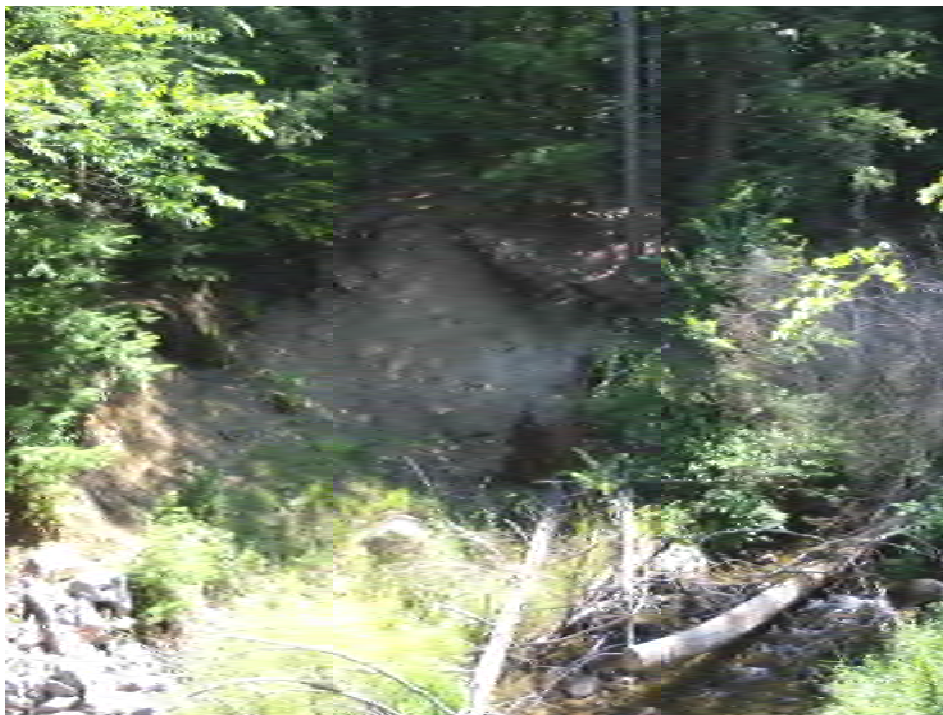
**Figure 8.11. Mass failure along eastern bank just upstream of Intervale Road Bridge in M02-A.**

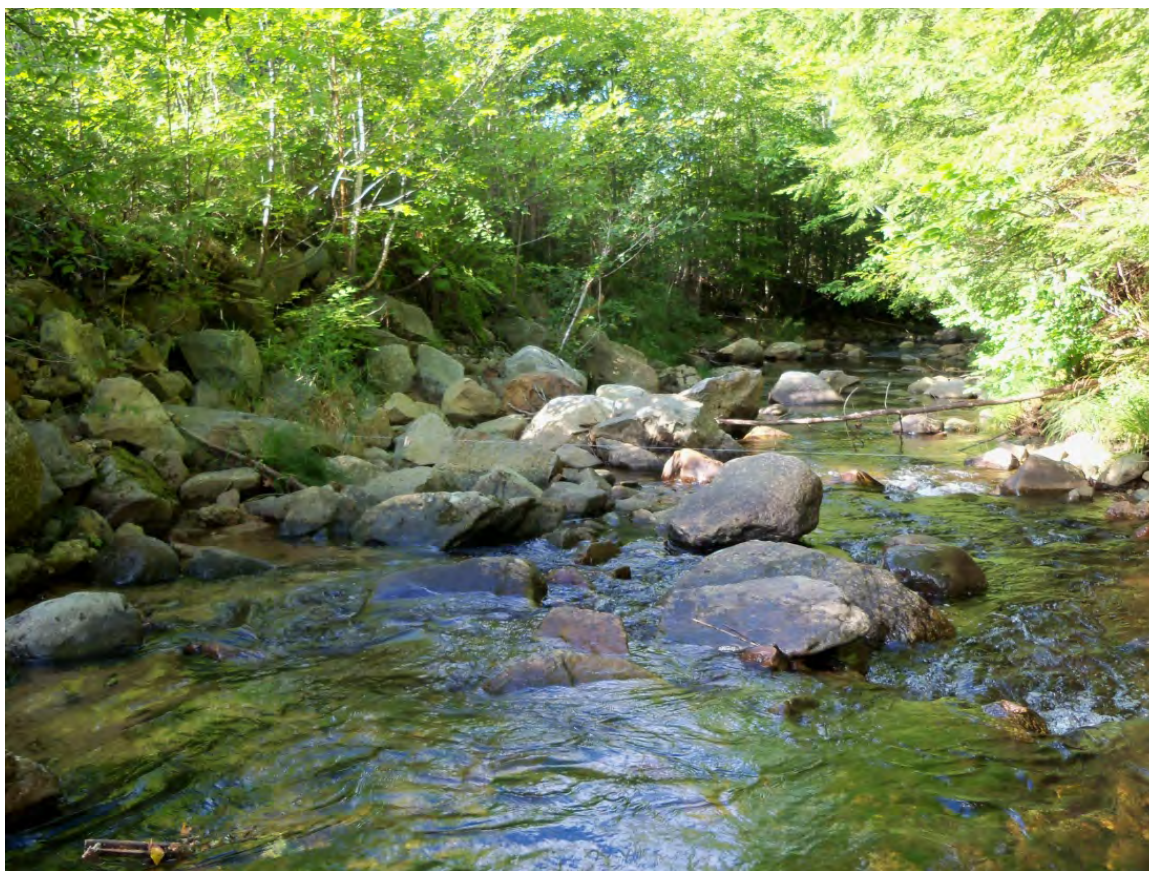
**Figure 8.12. Cobble dominated “B” stream type and failing riprap in segment M02-B.**

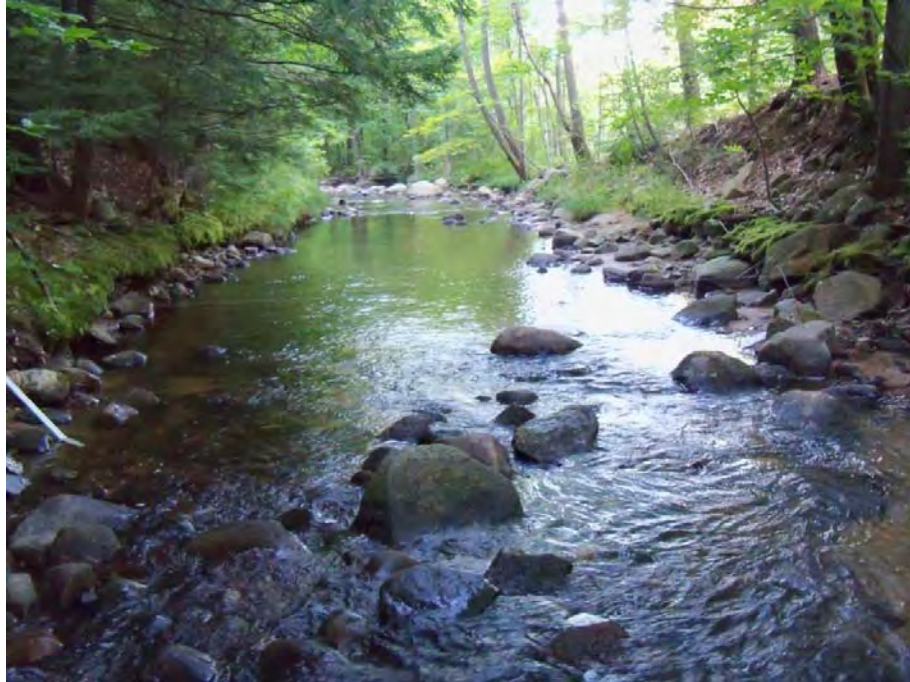
**Figure 8.13. Straightening and road encroachment in Segment M02-C.**

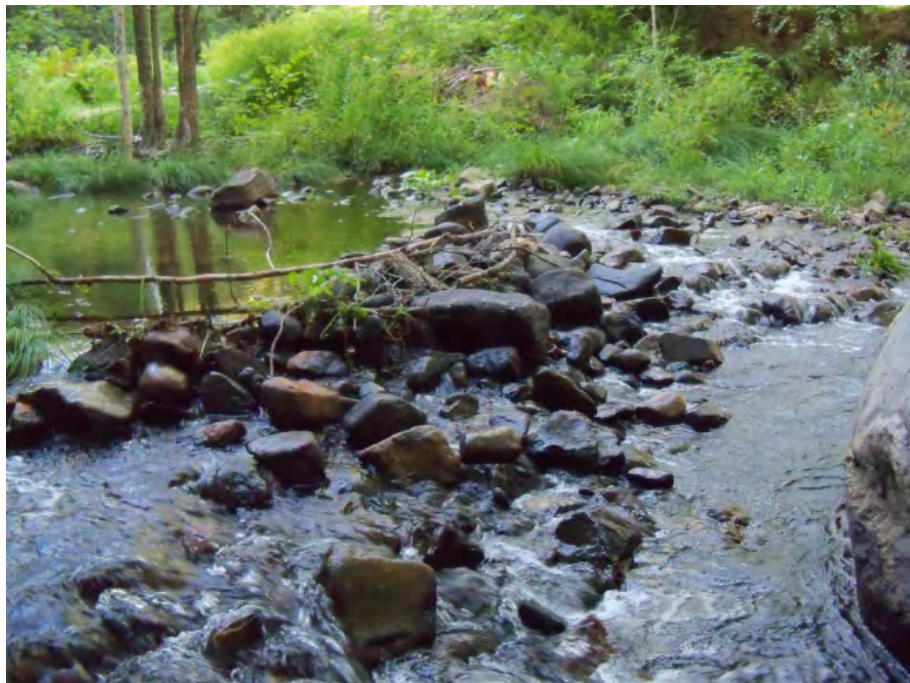
**Figure 8.14. Diagonal bar in Segment M02-C.**

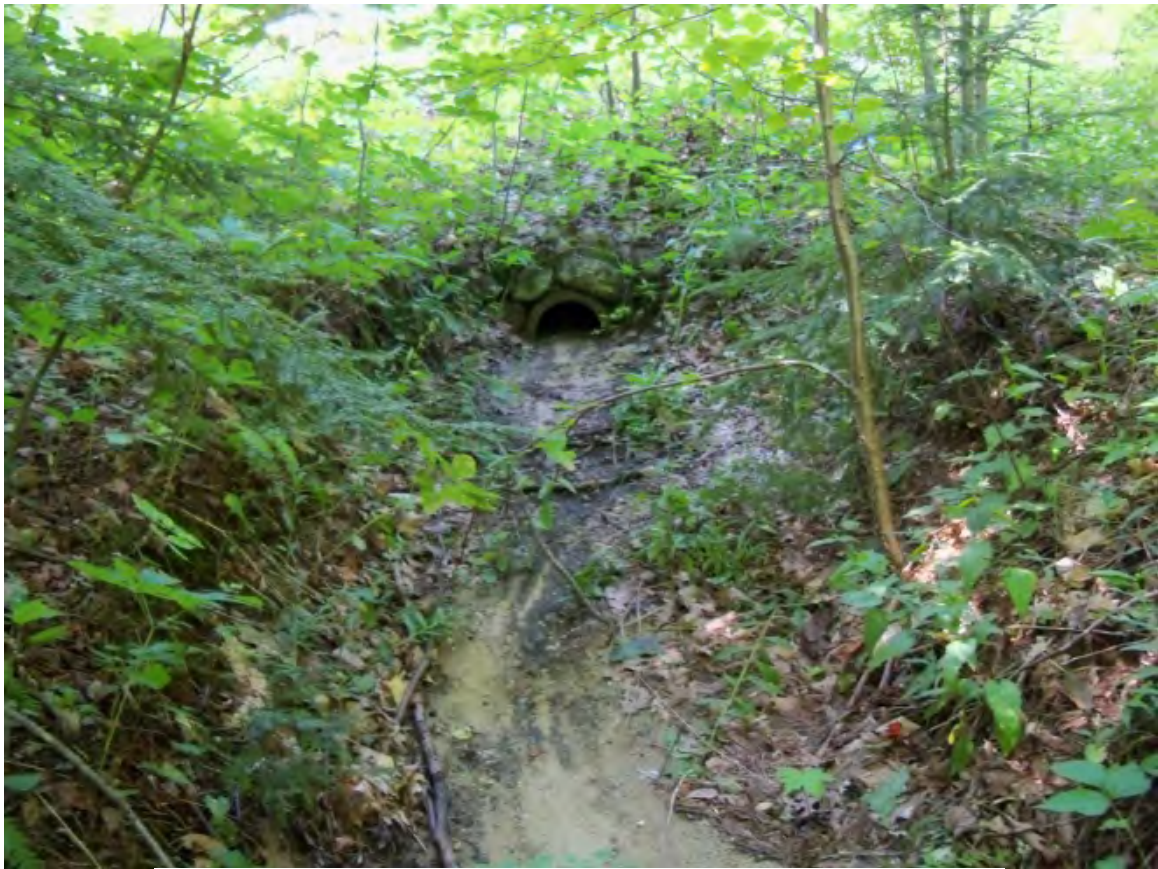
**Figure 8.15. Stormwater runoff from Intervale Road into M02-C.**

within Segment M02-C. Project #6 addresses improving stormwater runoff from Intervale Road into Gunstock Brook. The two bridges that cross Gunstock Brook in Segment M02-C (Intervale Road and Cherry Valley Road) are both noted as high priority for replacement due to being significantly undersized (Projects #7 and #9).

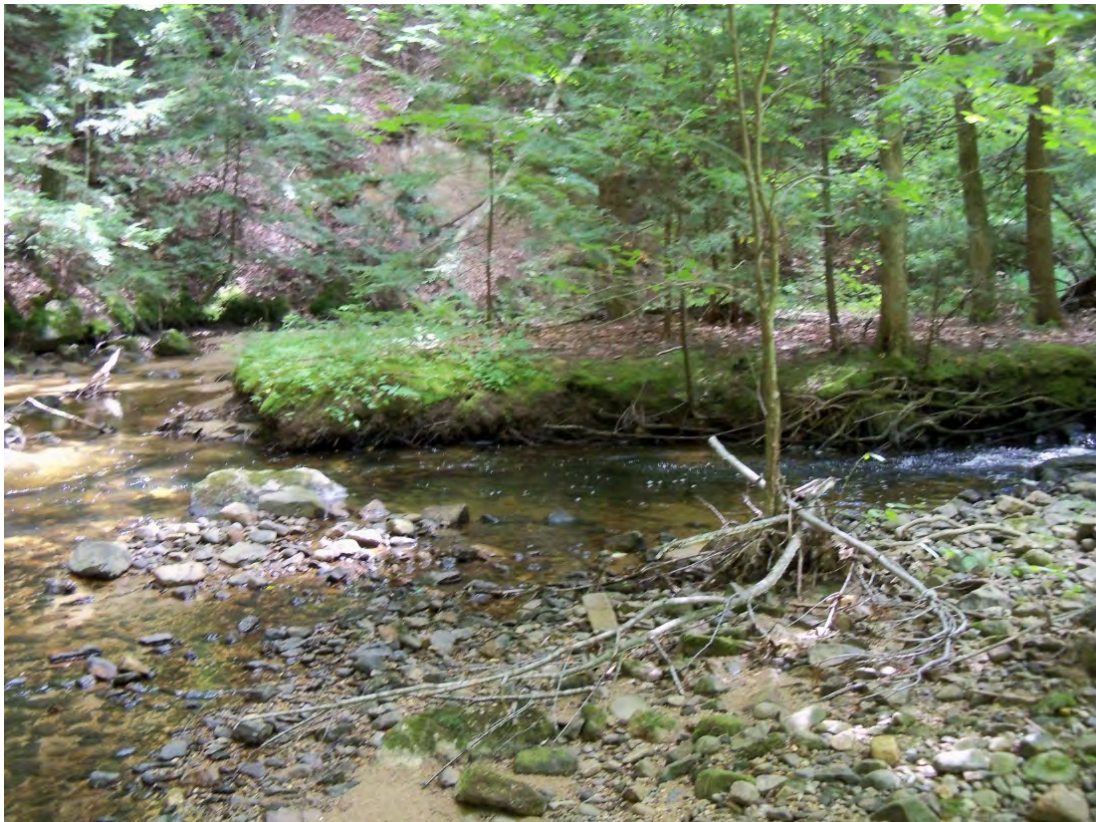
**Figure 8.16. Braided section of M03-A.**

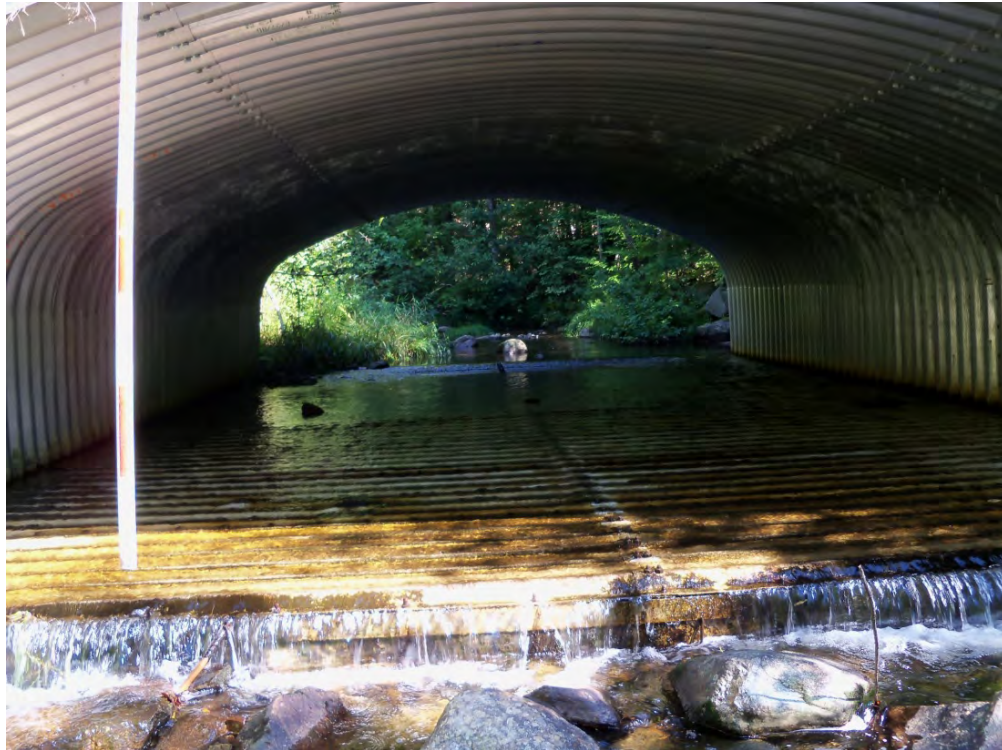
**Figure 8.17. Perched culvert at Town Garage Access Road in Segment M03-A impeding aquatic organism passage.**

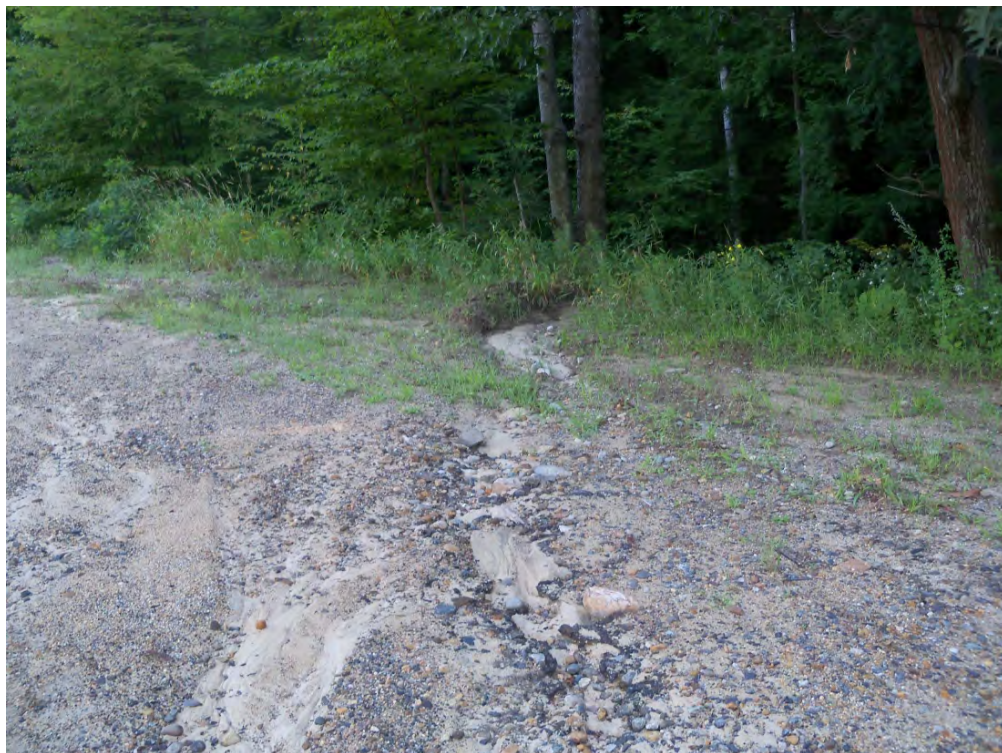
Stormwater runoff from the town garage parking lot is causing excess sediment into Gunstock Brook (Figure 8.18). Project # 11 would address the sediment loading by improving stormwater runoff from the parking area. Another project that would address sediment loading and runoff into Gunstock Brook (M03-A) is an investigation of an eroded swale (Figure 8.19) that is receiving discharge from a well (Project #12). Runoff from the swale is introducing significant sediment into Gunstock Brook (Figure 8.20).

**Figure 8.18. Sediment laden stormwater runoff from Town Garage parking lot in M03-A.**

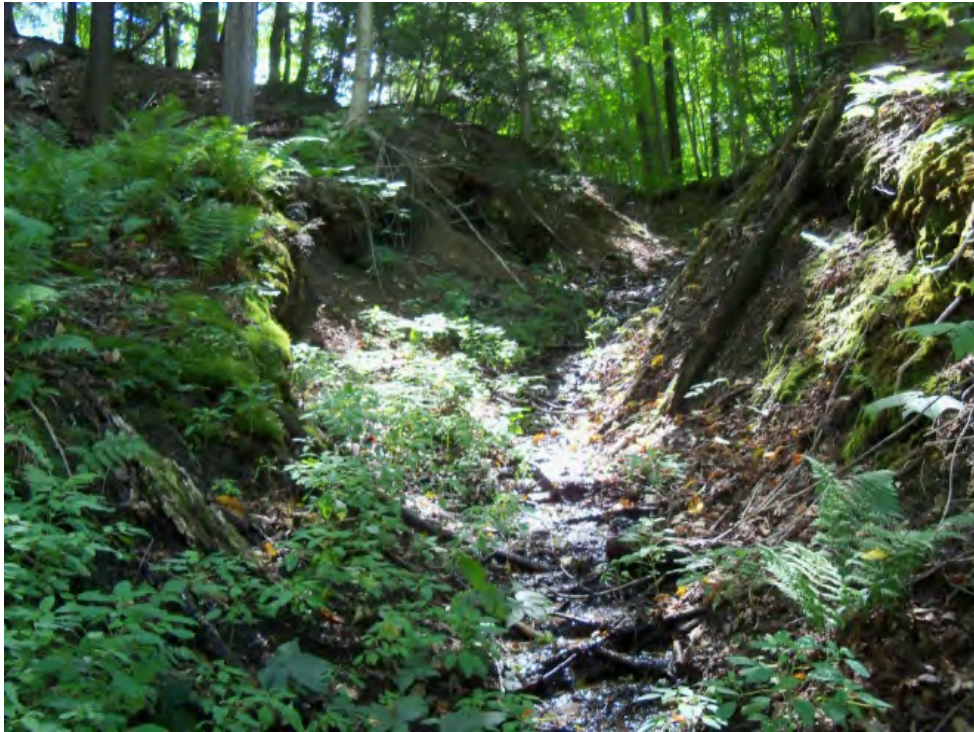
**Figure 8.19. Eroded swale in Segment M03-A.**

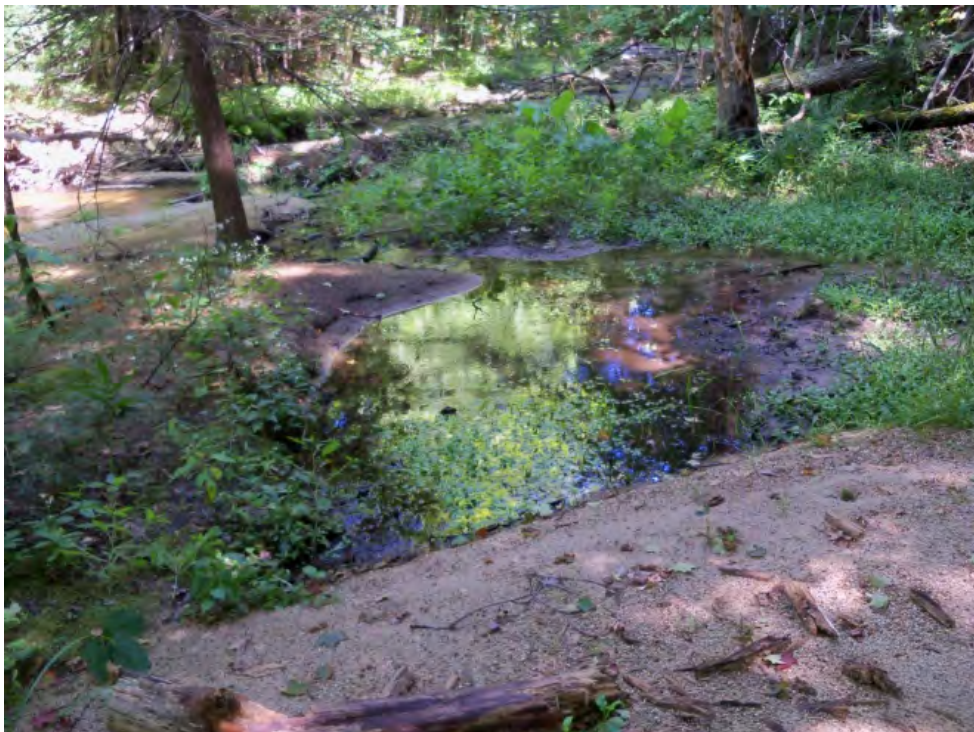
**Figure 8.20. Sediment from eroded swale in Segment M03-A.**

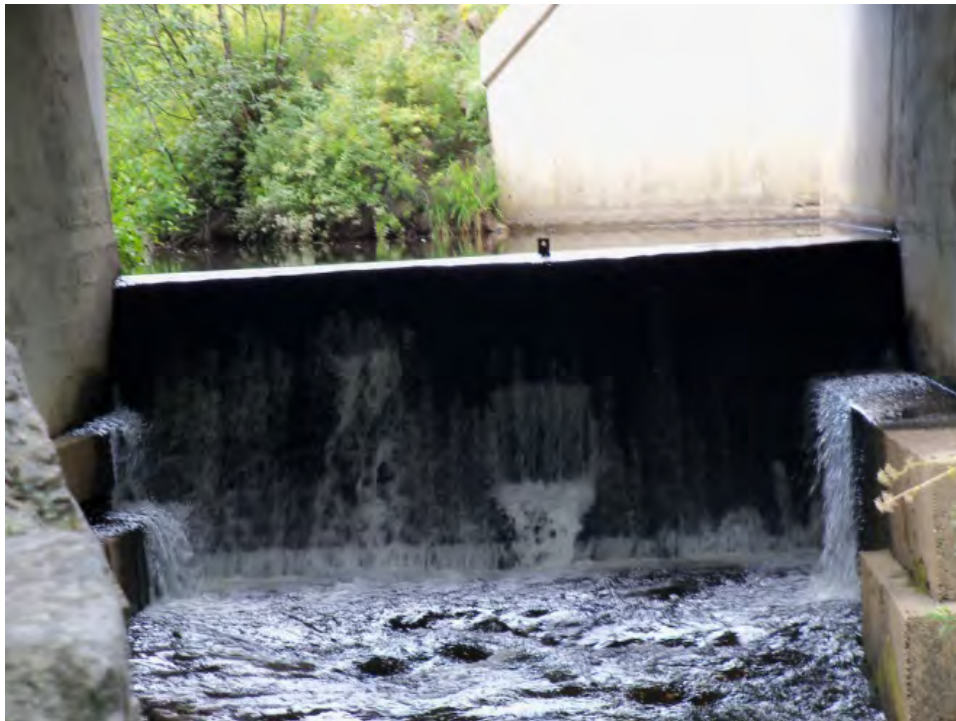
The dam under Belknap Mountain Road is impeding the passage of aquatic organisms. Downstream from the dam are rock walls lining the stream banks (Figure 8.23). The dam and rock walls are what is left of a sawmill that operated in the 1800s (Gilford Historic District Commission, 1990). During this time period, the dam impounded water up into Reach M04. The recreational area was called the Millpond and was used as a fishing and ice skating spot. Now the area contains tennis courts. An alternatives analysis is recommended to improve habitat connectivity at the former mill site and determine if it is feasible and beneficial to remove the dam and rock walls (Project #13). Historic preservation may be a consideration regarding removal of this dam.

**Figure 8.22. Dam at Belknap Mountain Road crossing in M03-B.**

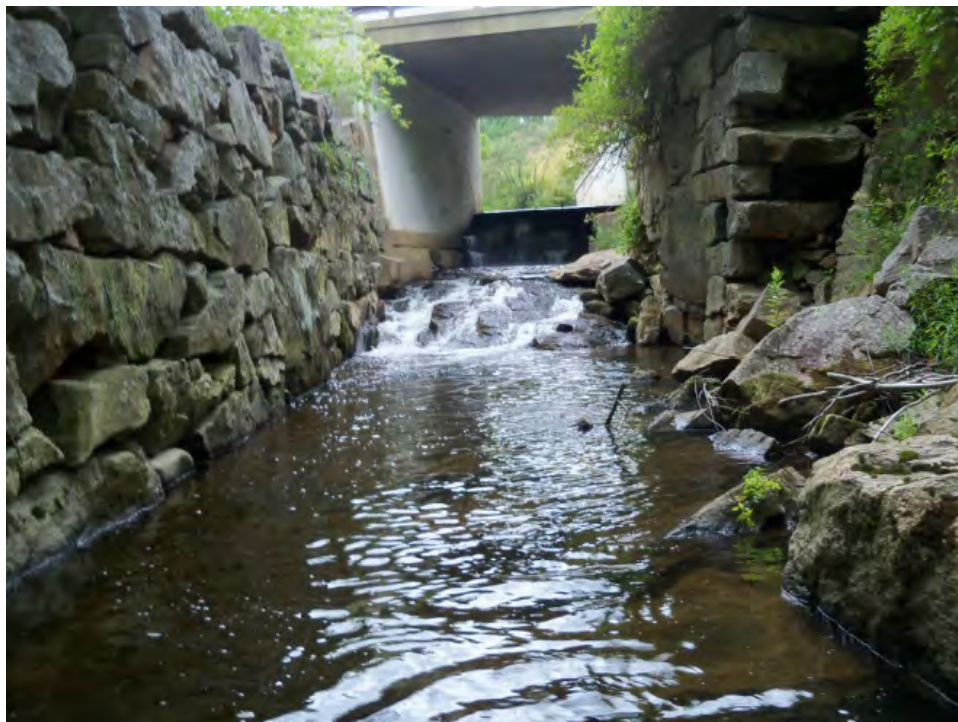
**Figure 8.23. Rock walls downstream of the Belknap Mountain Road crossing in M03-B.**

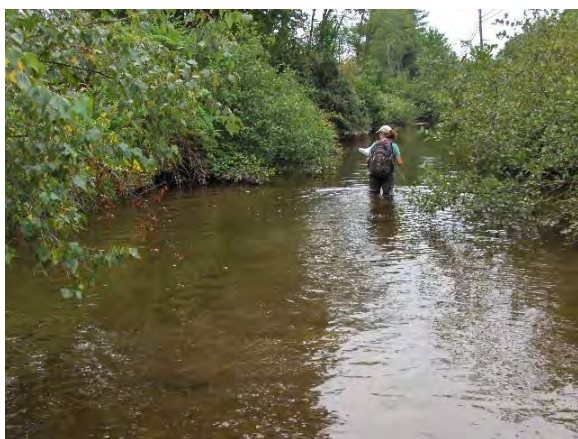
**Figure 8.24. Straightened section of M04-A.**

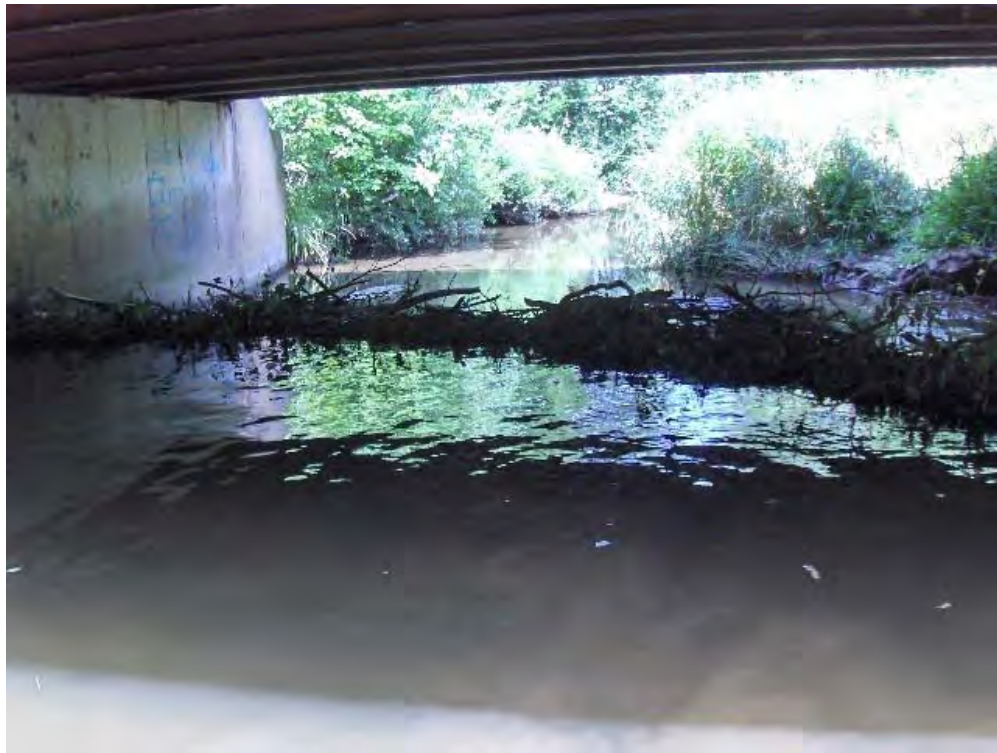
Approximately halfway through the segment heading upstream, Gunstock Brook flows past the Alvah Wilson Middle School and then continues under Alvah Wilson Road Bridge. There is currently a beaver dam within the structure that may cause some problems in the future for stream flow through the bridge (Figure 8.26). There are also two old abutments within M04-A which are constricting the stream channel. One abutment is in the downstream straightened section, but another one is located approximately 850 feet from the top of the segment (Figure 8.27).

**Figure 8.26. Beaver dam within Alvah Wilson Road Bridge in M04-A.**

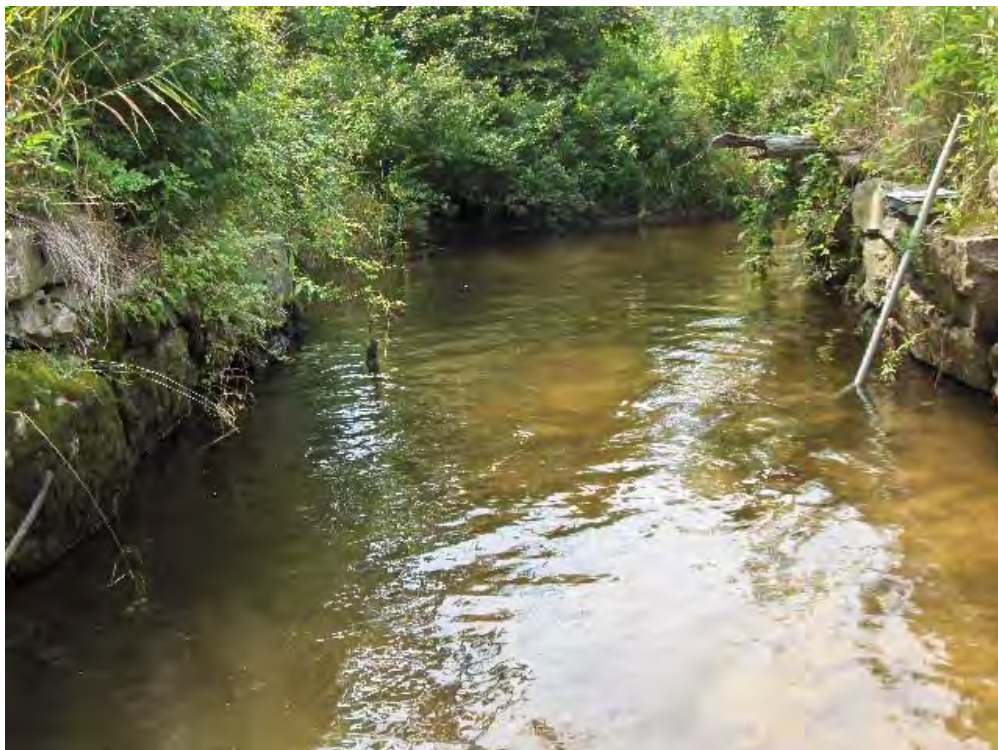
**Figure 8.27. Old abutment constricting the stream channel in M04-A.**

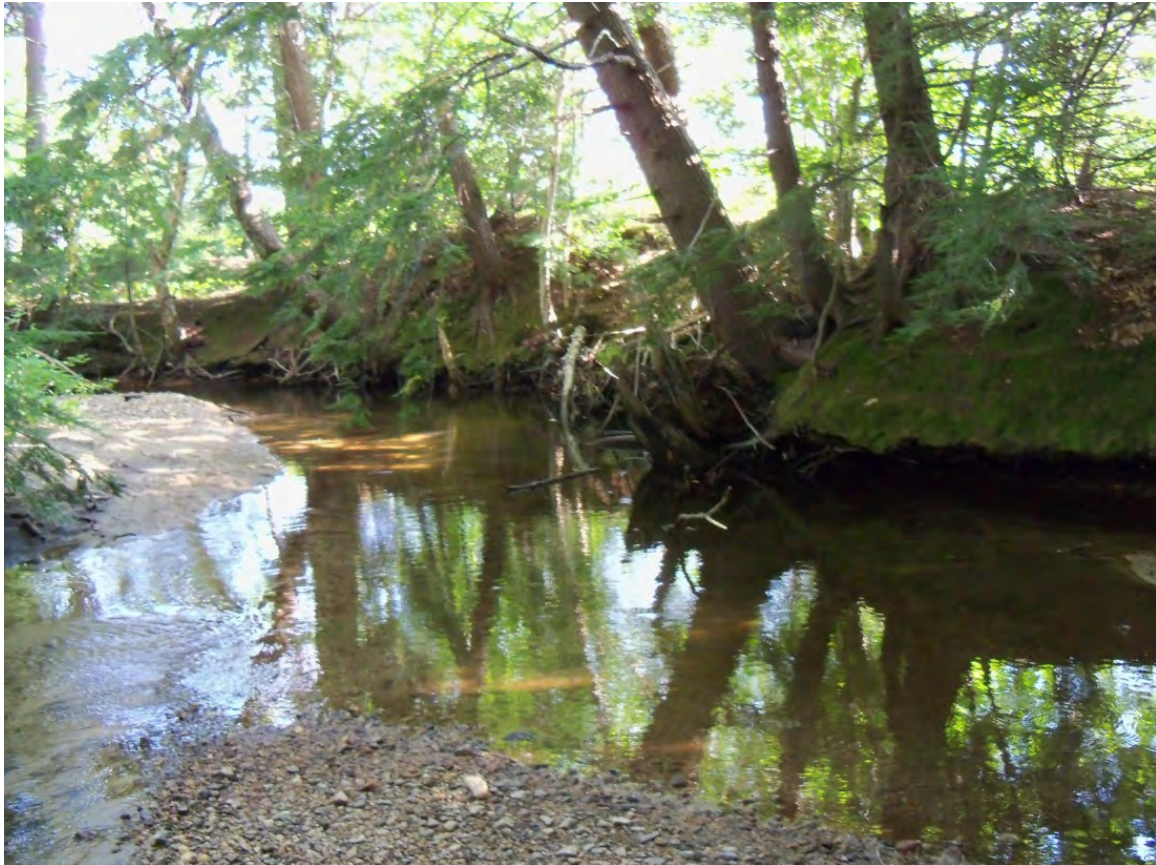
**Figure 8.28. Moss covered undercut bank in M04-B.**

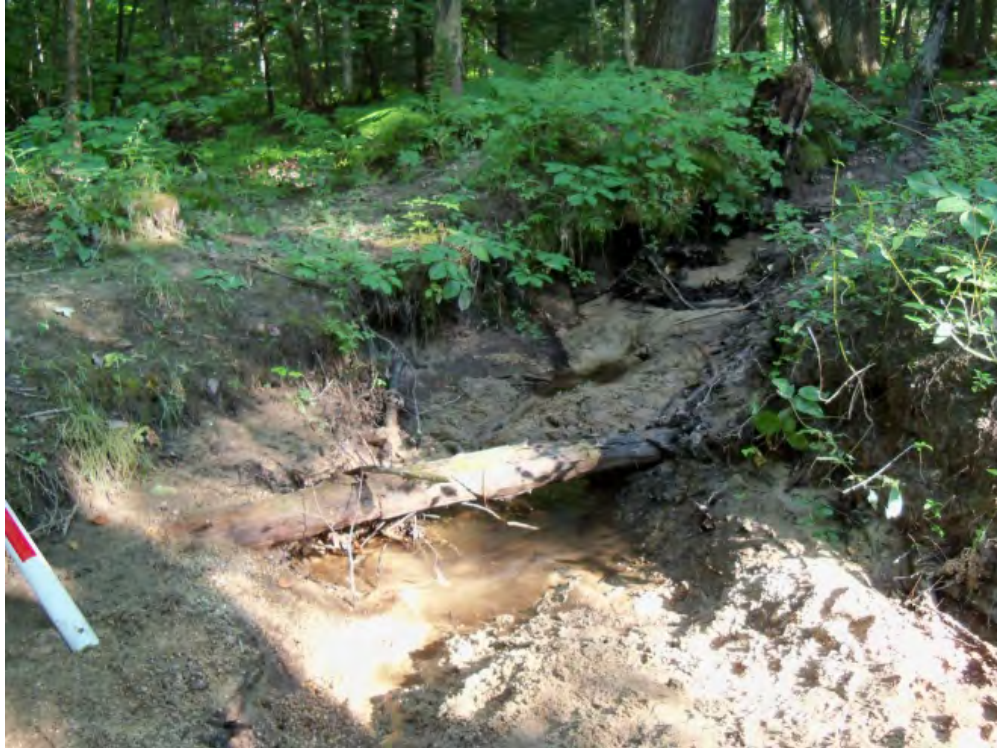
**Figure 8.29. Tributary contributing sediment to Gunstock Brook in Segment. M04-B.**
