# **Gunstock Brook Watershed Stream Geomorphic Assessment**

**Gilford, New Hampshire  
July 9, 2012**

Prepared by:  
Bear Creek Environmental, LLC  
297 East Bear Swamp Road  
Middlesex, Vermont 05602

Prepared under contract to:  
Belknap County Conservation District  
2 Airport Road, Unit #1  
Gilford, NH 03249

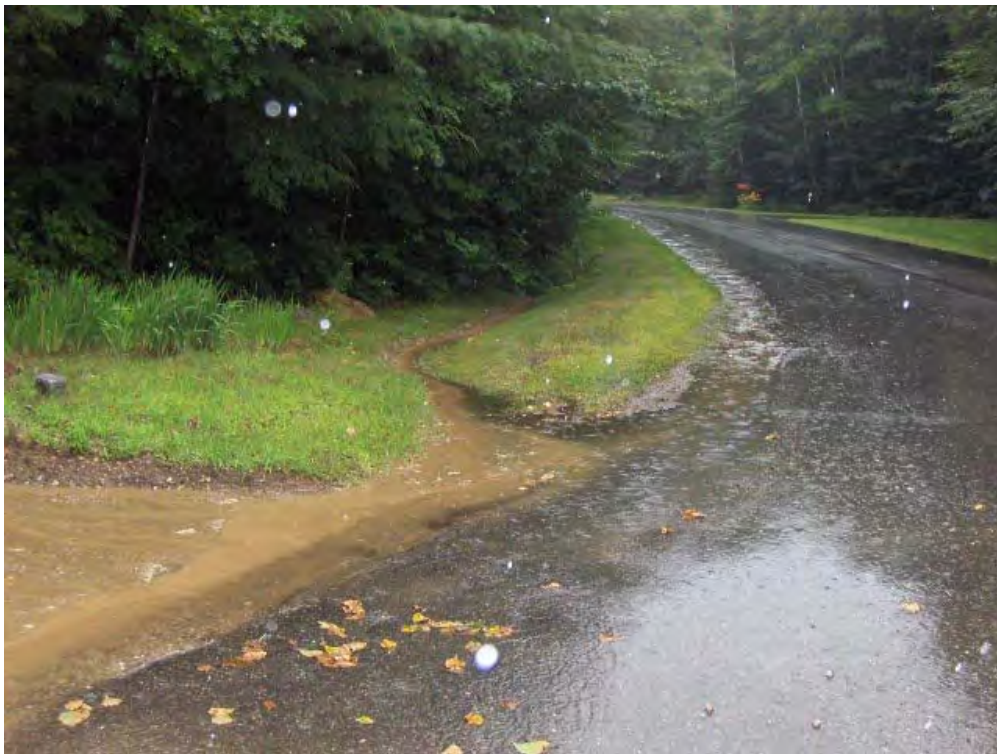
**Figure 8.30. Turbid stormwater runoff on Doris Drive on August 21, 2012.**

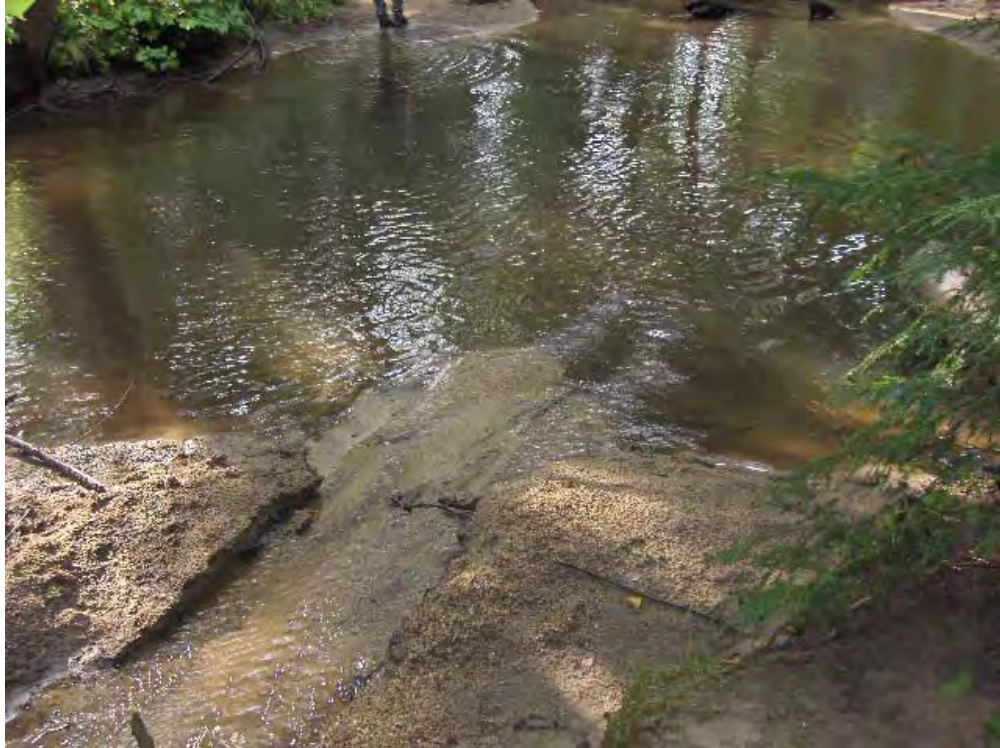
**Figure 8.31. Sediment loading from sandy tributary into M04-B.**

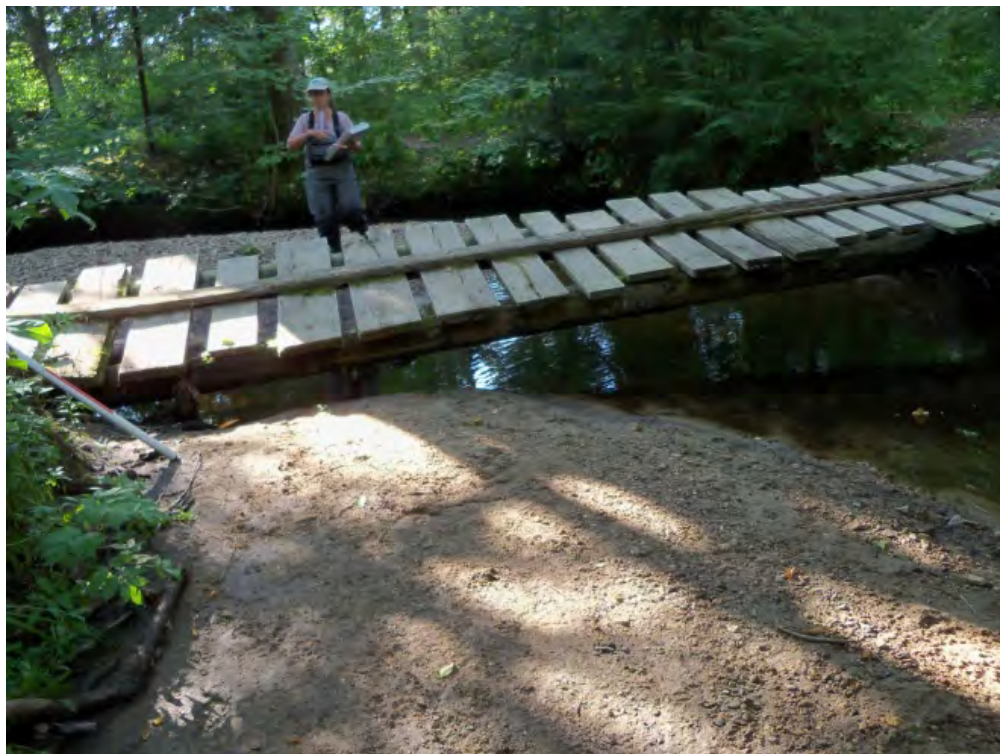
A wooden bridge along Gunstock Brook is currently collapsing (Figure 8.32). Sediment and debris are blocking the bridge that does not appear to be in use. Removal of the bridge is recommended (Project #15).

**Figure 8.32. Collapsing wooden bridge in M04-B.**

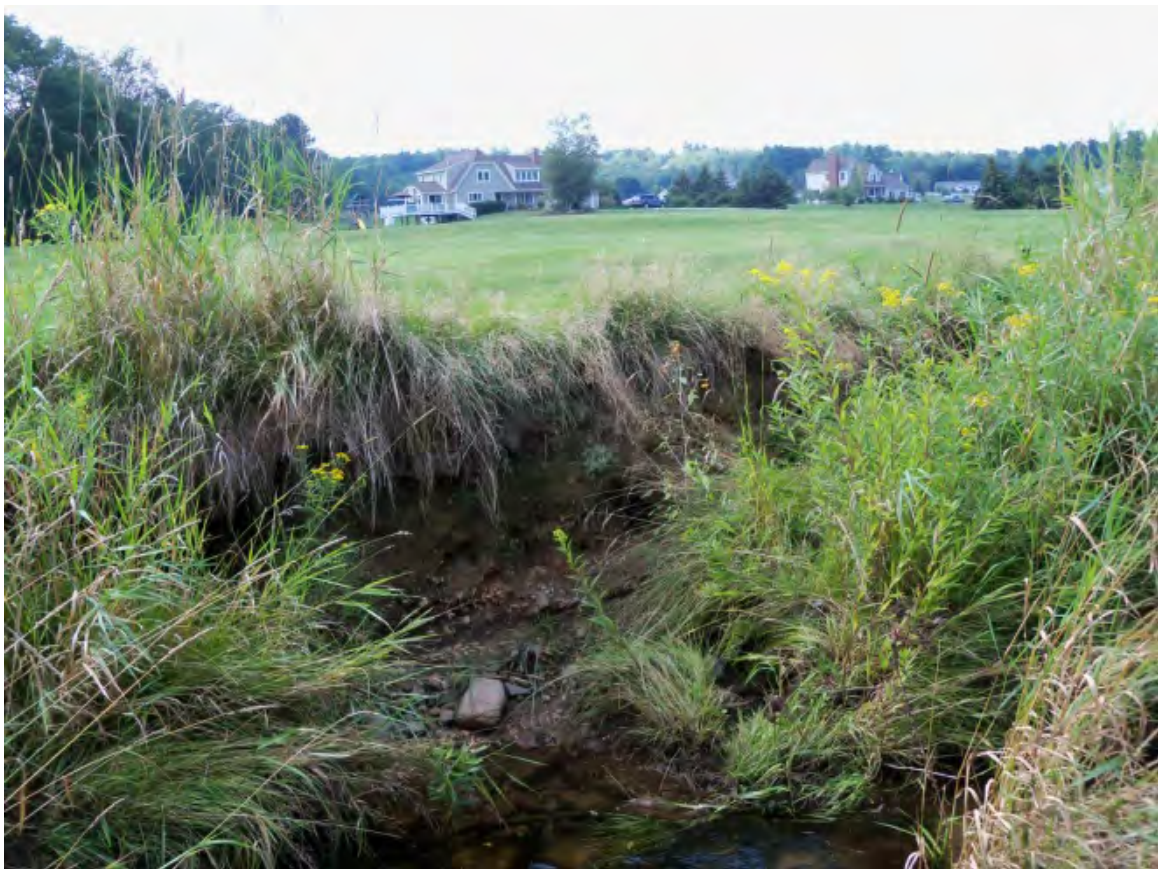
**Figure 8.33. Lack of riparian buffer and streambank erosion in M04-C.**

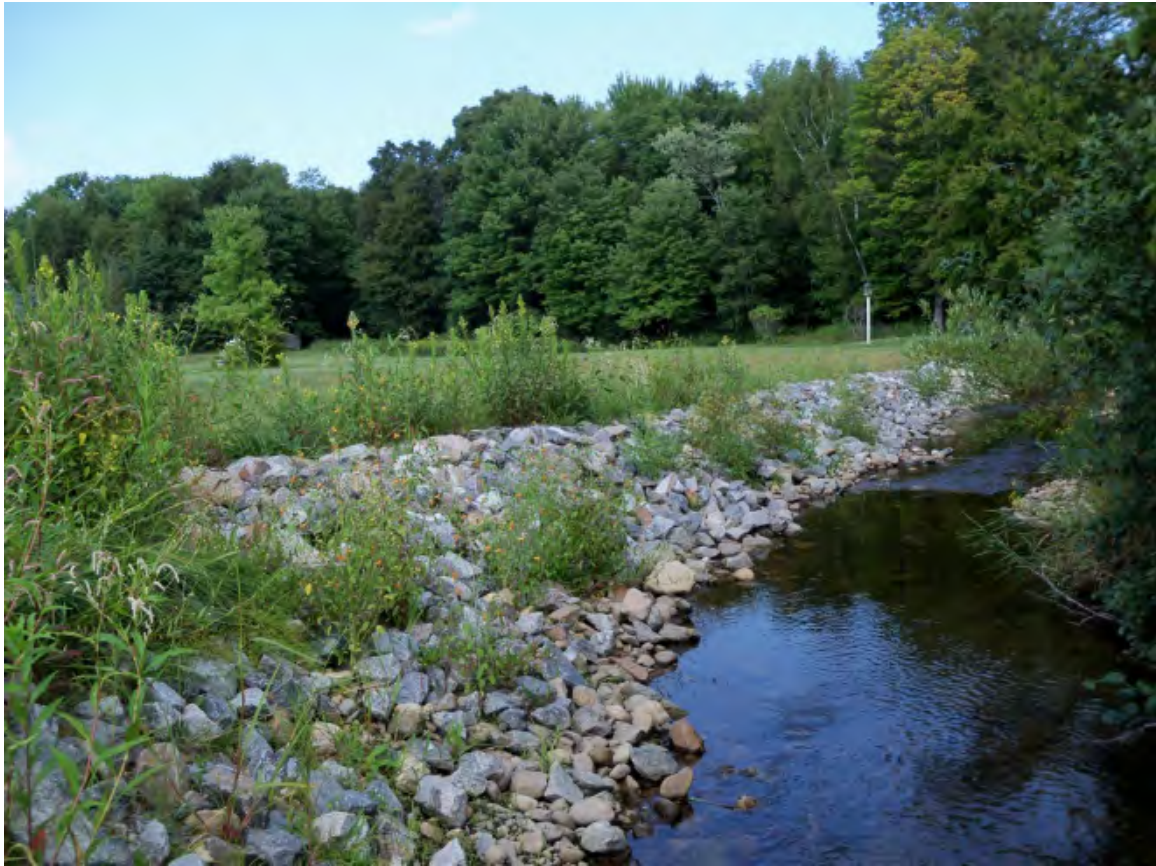
**Figure 8.34. Channel alteration and streambank armoring in M04-C.**

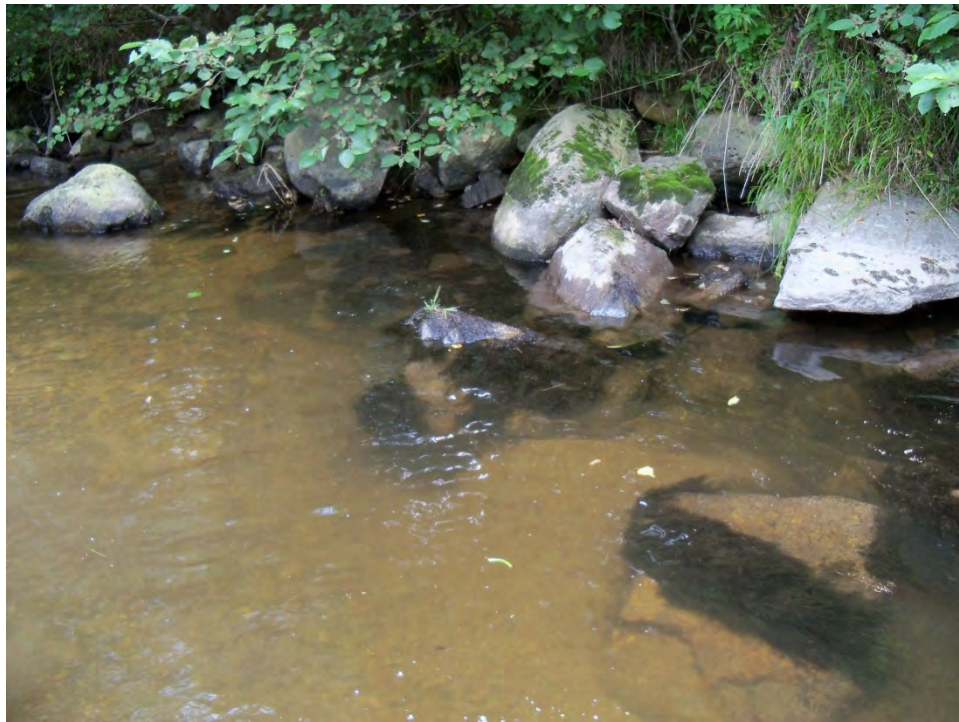
**Figure 8.36. Failing rip-rap in M05-B.**

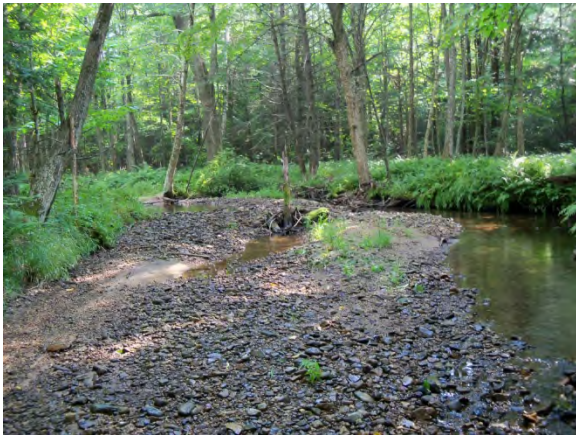
**Figure 8.37. Large diagonal bar showing major aggradation in M05-C.**

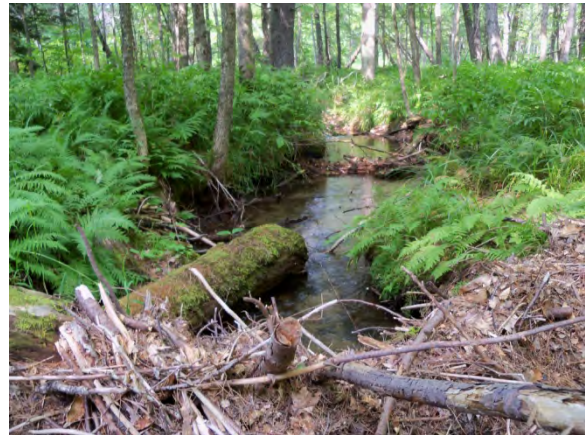
**Figure 8.38. Channel avulsion indicating major planform change in M05-C.**

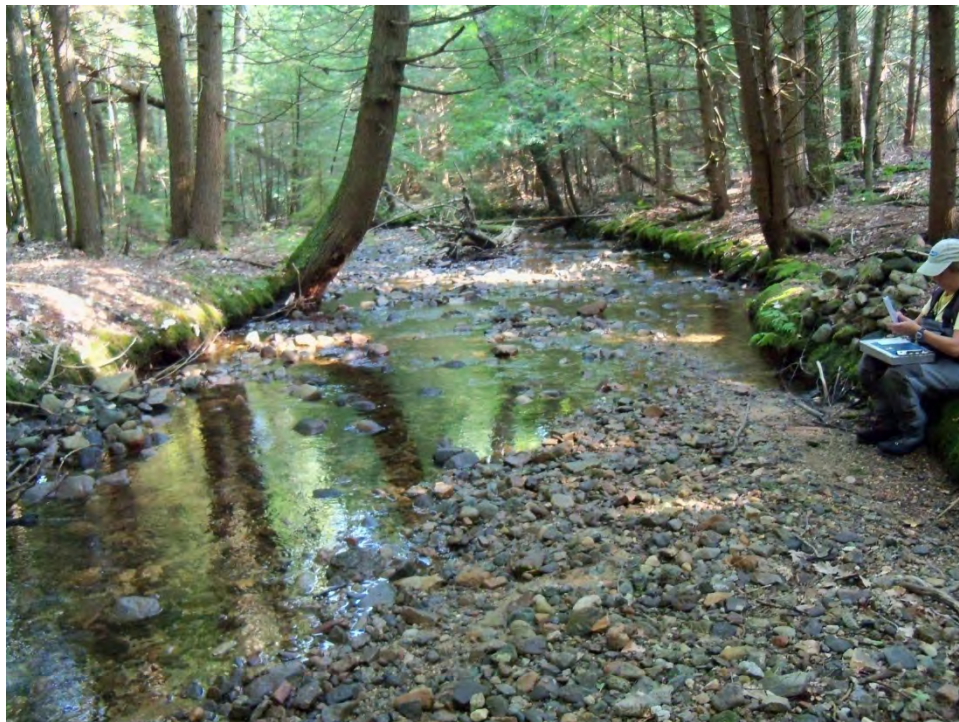
**Figure 8.40. Depositional features in T2.01-A caused by drop in slope and perhaps upstream sediment source.**

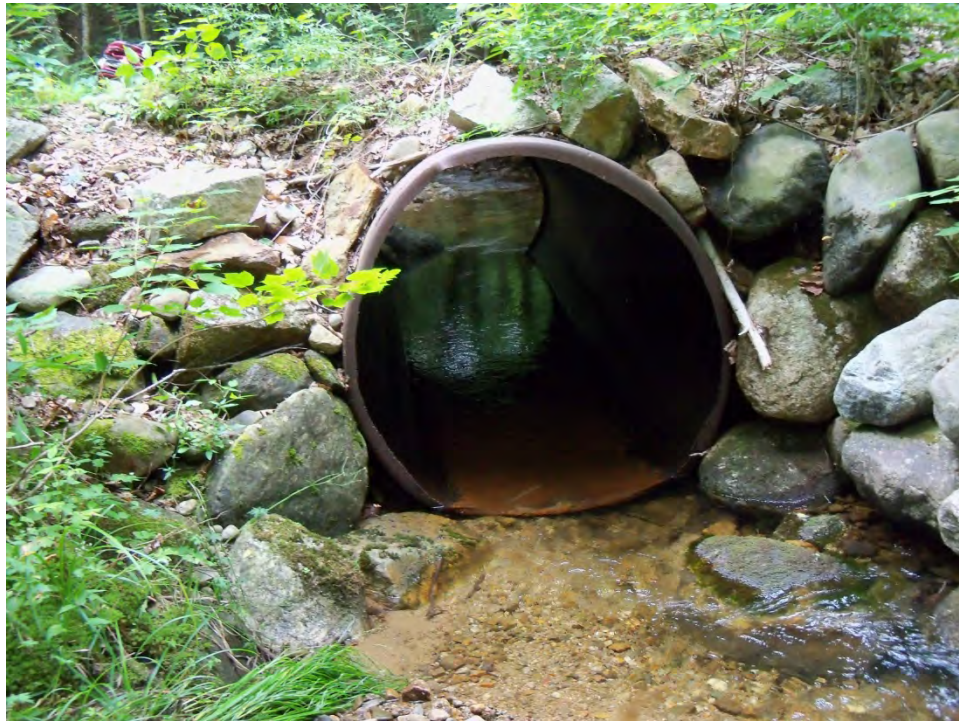
There is one stream crossing in T2.01-A that is significantly undersized and causing geomorphic instability. A culvert at a trail crossing (Figure 8.41) is in poor condition (rusted bottom and deformed) and has been given a high priority for replacement (Project #19) due to its reduced aquatic organism passage and geomorphic incompatibility. The replacement of this undersized structure is also a recommendation of NRCS (see page 51).

**Figure 8.41. Undersized and rusted culvert in T2.01-A.**
