SHORELINE SURVEY | MEMORANDUM

TO: Pat Tarpey, Lake Winnepesaukee Association
FROM: Forrest Bell, FB Environmental Associates
SUBJECT: **2015 Moultonborough Bay Inlet and Two Ponds: Shoreline Survey Results**
DATE: March 7, 2016 (Updated July 22, 2016)
CC: Margaret Burns, FB Environmental Associates

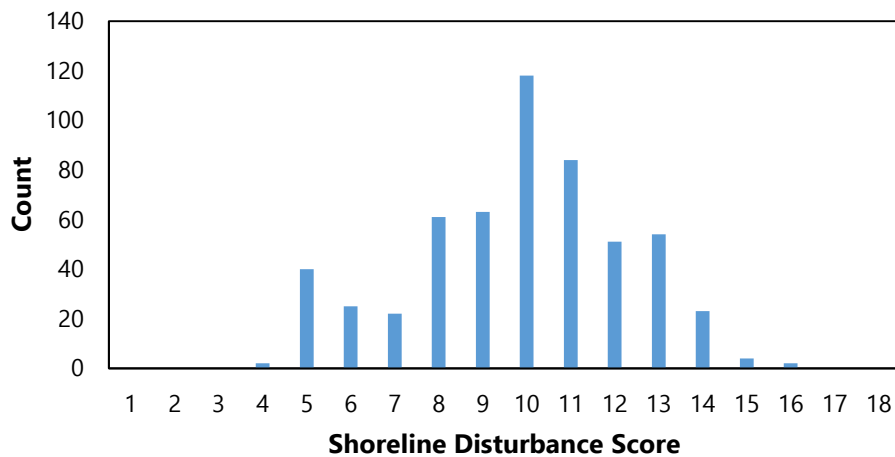
Ranging from 4 to 16, high shoreline disturbance scores were primarily driven by parcels that had poor buffers (*Average Buffer Score* = 3.0; Table 1; Figure 1). A total of 6 high-priority parcels scored 15-16 out of a maximum score of 18. A total of 330 medium-priority parcels scored between 10-14. The remaining low-priority parcels (213) scored less than 10, indicating minimal impact to lake water quality.

Figure 1. Moultonborough Bay Inlet Shoreline Disturbance Scores.

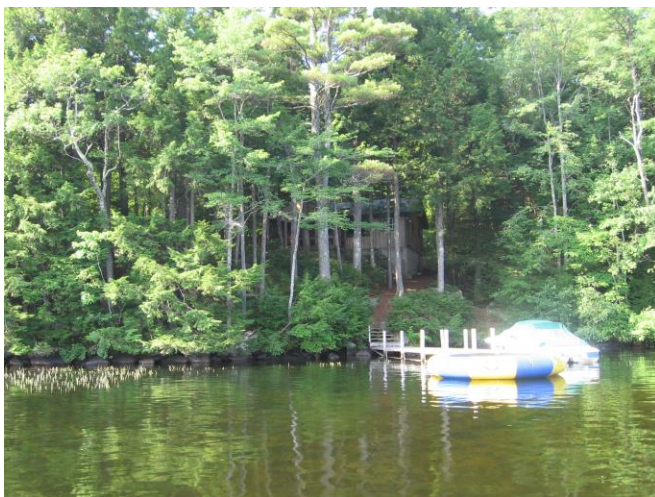
Photo 2. Moultonborough Bay Inlet parcel receiving a final score of 9.

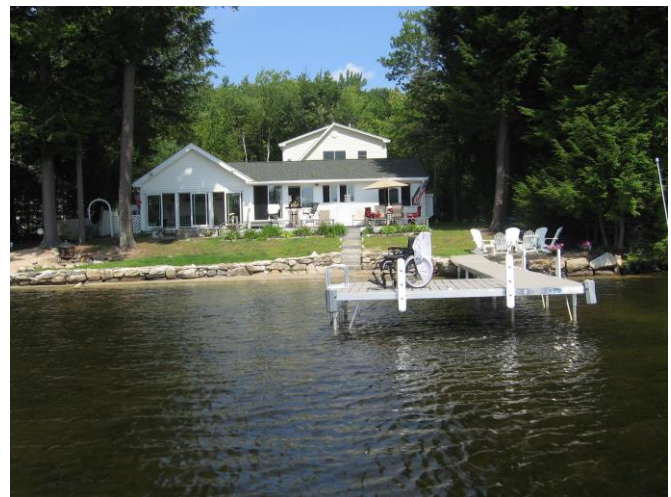
Photo 3. Moultonborough Bay Inlet parcel receiving a final score of 14.

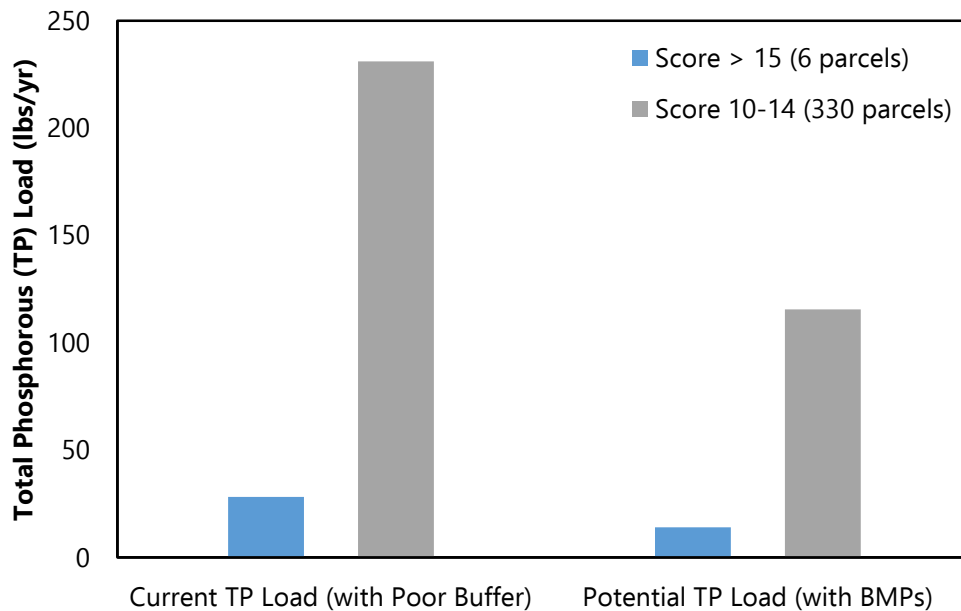
Pollutant loading estimates were based on the shoreline disturbance scores (Figure 1). The 6 parcels with a score of 15 or greater generate an estimated 28.2 lbs. of phosphorus load to MBI annually¹. If shoreline landowners were to create adequate buffers and install other shoreline Best Management Practices (BMPs) on all properties (at a 50% BMP efficiency rate), the annual reduction would be 14.1 lbs. of phosphorus. The 330 parcels with scores 10-14, are contributing an estimated 231.0 lbs. of phosphorus annually². Remediation efforts on all properties scoring 10-14 using a 50% BMP efficiency rate could result in the annual reduction of 115.5 lbs. of phosphorus (Figure 2).

Figure 2. Moultonborough Bay Inlet current and future total phosphorus (TP) load estimates. Current TP loading is representative of the amount of TP (lbs/yr) found in runoff generated from a particular group of parcels (i.e., all parcels scoring >15 or between 10 and 14). Potential TP load is a rough estimate of the TP load from this same set of parcels if BMPs were installed at a 50% efficiency rate.

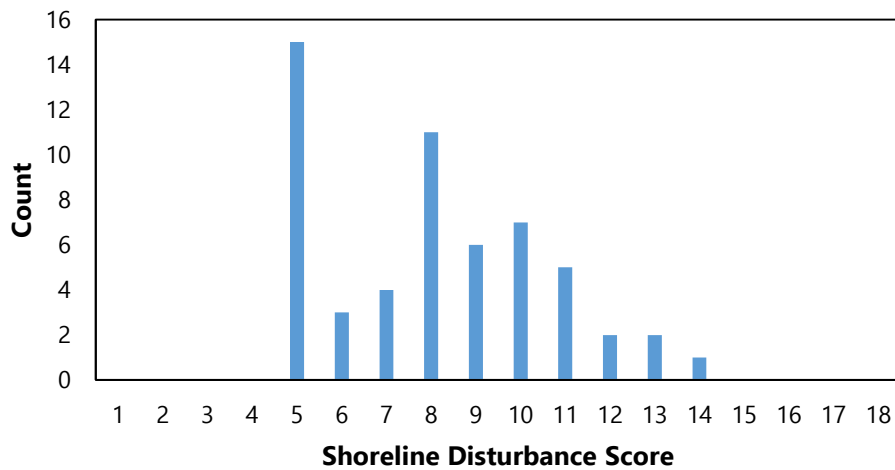
Fifty-six (56) parcels were evaluated by Beverly Nelson along Lees Pond on September 2, 2015. Ranging from 5-14, the average shoreline disturbance score for Lees Pond was 8.1 (Table 3; Figure 2). Lees Pond scored high for the setback distance of development from the shoreline (*Average Score of 2.1*; Table 3). The parcel lots on Lees Pond were smaller in comparison to Garland Pond and had more residential development aside from one small parcel owned by the Nature Conservancy.

Figure 2. Shoreline disturbance scores for parcels around Lees Pond.

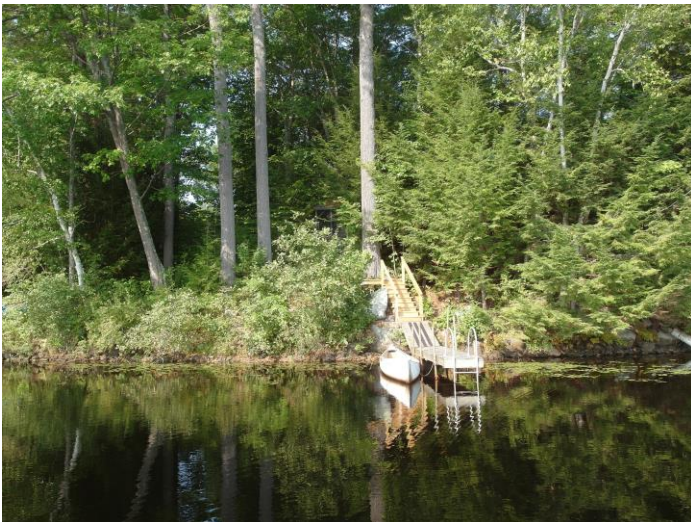
Photo 5. A shoreline parcel on Lees Pond receiving a final score of 7.

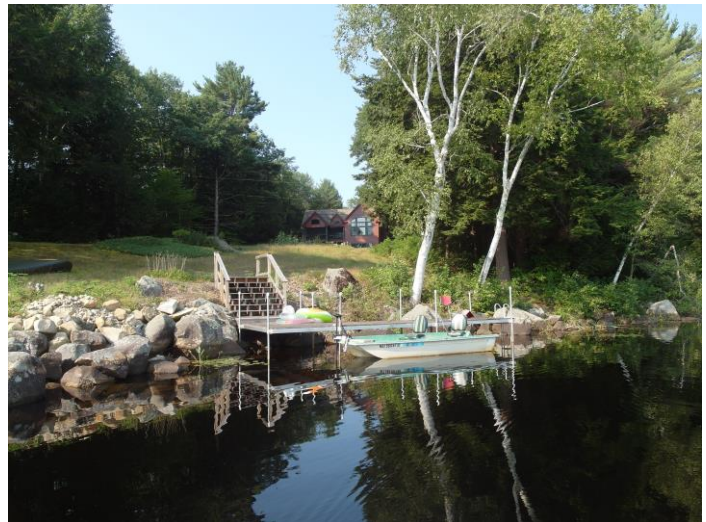
Photo 6. A shoreline parcel on Lees Pond receiving a final score of 10.
