5.0 Identification of Pollution Sources in the Watershed

5.1 Watershed Nonpoint Source Survey

5.2 Shoreline Survey

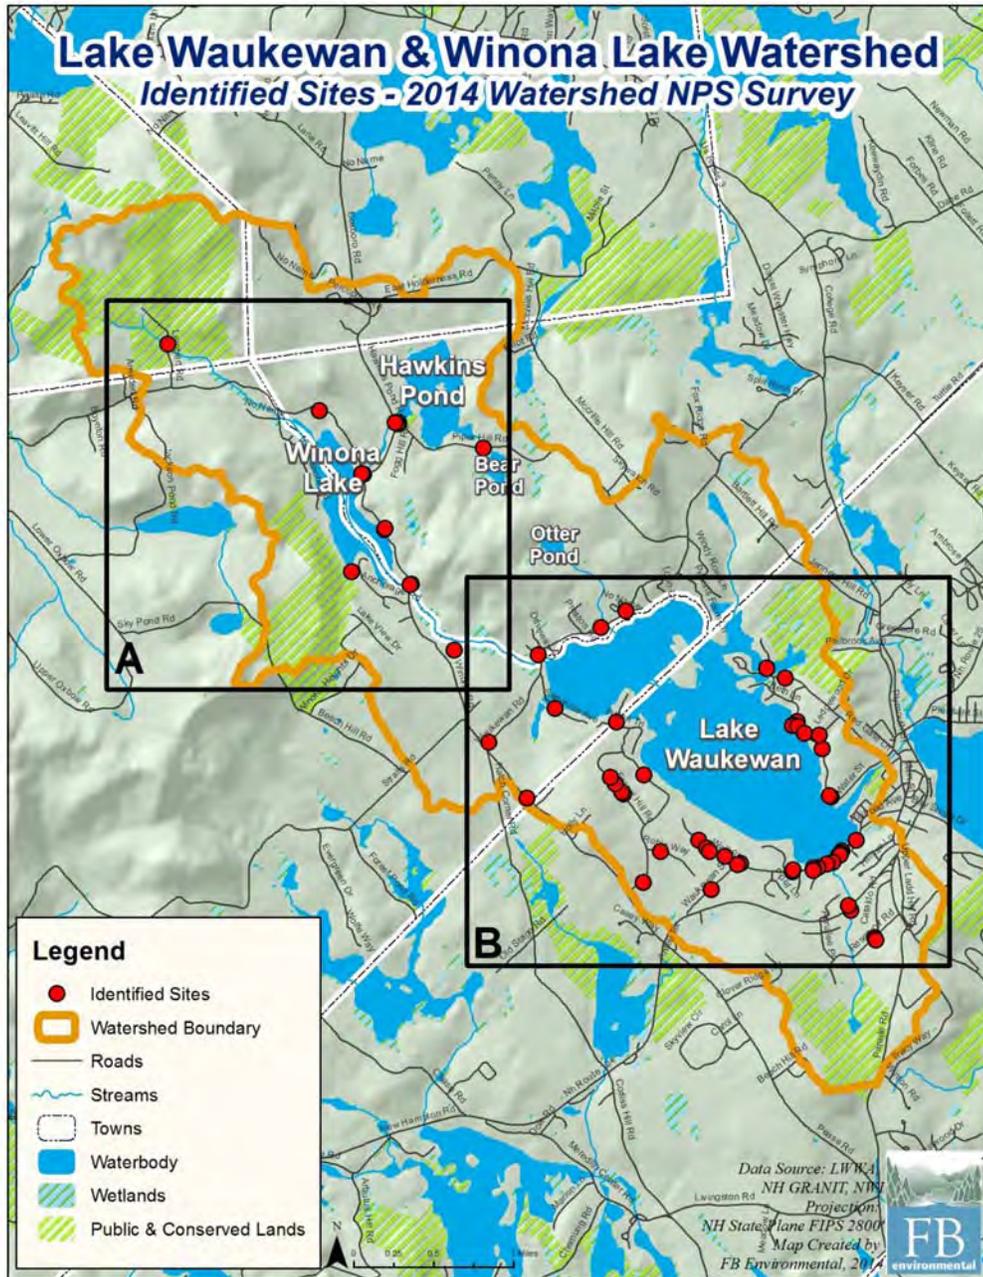
Figure 26. Map of Nonpoint Source Sites identified in the Waukewan watershed survey. Maps A and B can be found in the Appendices.

Volunteers and technical staff identified **65 sites** in the Lake Waukewan and Winona Lake watershed that are currently impacting or have the potential to impact water quality in the lake (Figure 26). Some key conclusions include:

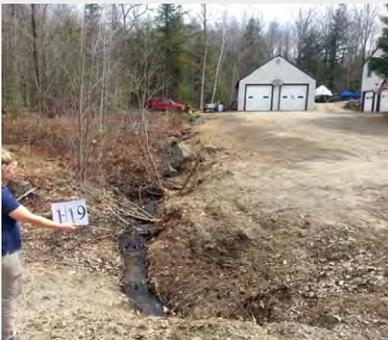
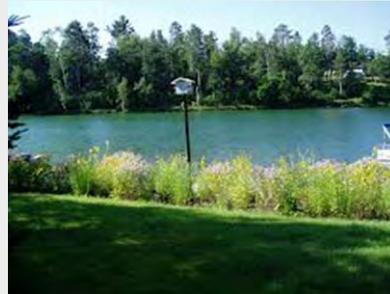
Problem: Lack of Buffer or Inadequate Buffer

Buffer Zone along lake shore slows runoff from adjacent areas and prevents erosion.

Solution: Control runoff from impervious surfaces from eroding the lake shore or adjacent streambank by establishing a vegetative buffer or no-mowing zone.

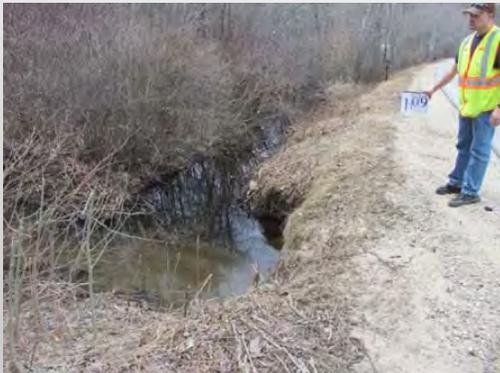
Problem: Severe road shoulder erosion resulting in sediment delta into stream

*Plunge Pool
Collecting runoff*

Solution: Remove road berms. Resurface road with new material and reshape. Install a plunge pool and direct runoff into forested buffer.

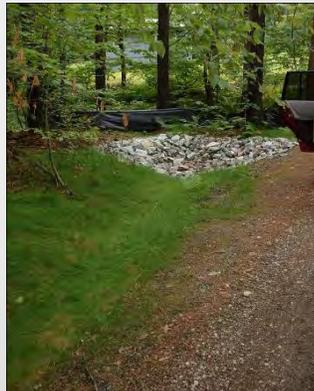
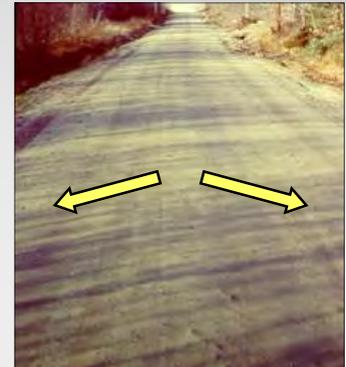
*Re-grade Road & add
new surface material*

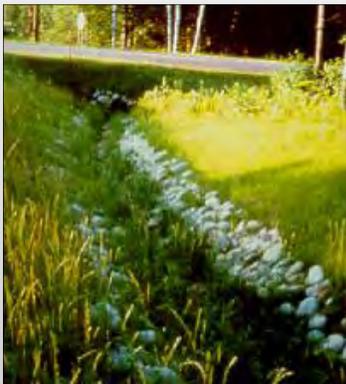
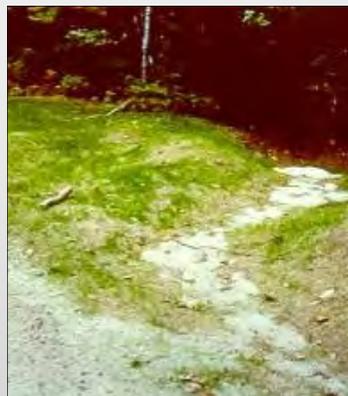
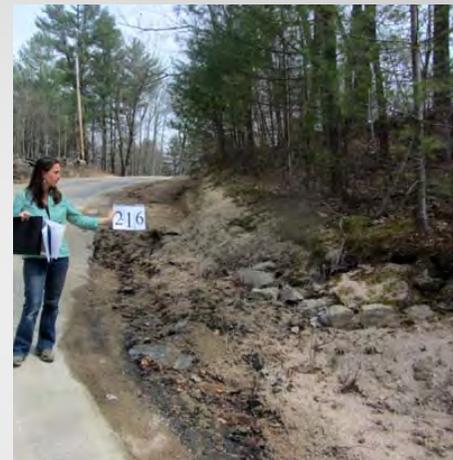
Problem: Severe ditch erosion

*Ditch armored with
stone and vegetation*

*Turnouts direct water
into vegetated areas*

Solution: Line ditch with rock and vegetate for stability. Install turnouts directing water into forested buffer.

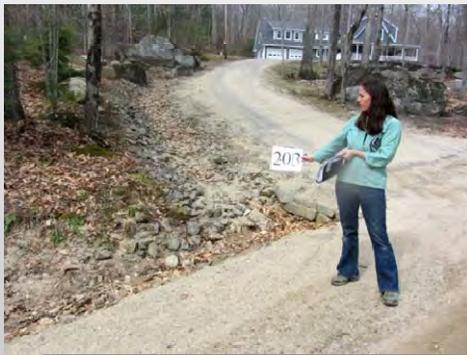
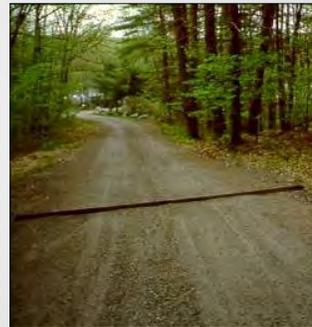
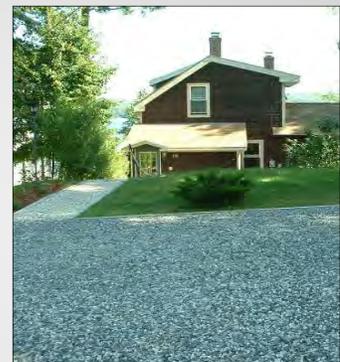
Problem: Surface erosion

Rubber razors direct water off driveway and into vegetation

Solution: Re-grade driveway. Install rubber razors or water bars.

Resurface driveway with hard-packing, cohesive surface material.

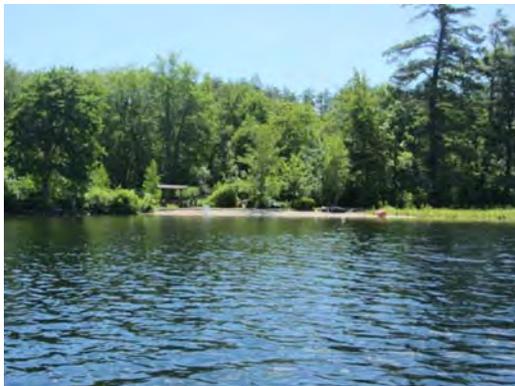
Figure 30. Lake Winona parcel receiving a final score of 7

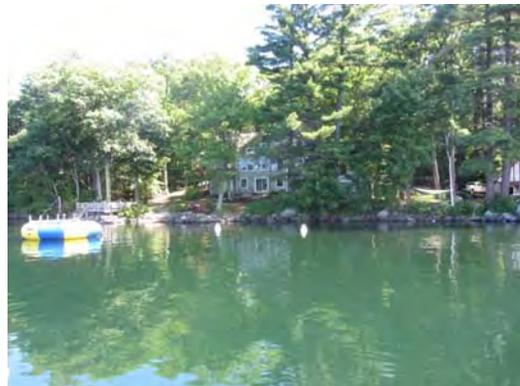
Figure 31. Lake Waukewan parcel receiving a final score of 12

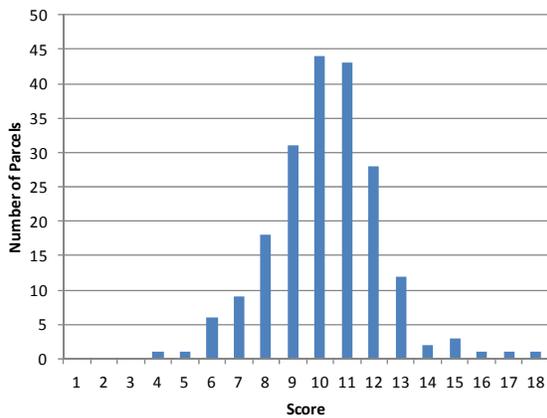
The overall average combined shoreline disturbance score of both lakes was 9.1. High scoring parcels on both lakes are those scoring a 10 or higher (Figure 32, Figure 33). These sites tended to have inadequate buffers, some evidence of bare soil, and structures within 75 feet of the shoreline. This trend tells us where the greatest improvements can be made around the lake shorelines, such as through planting stronger buffers and installing erosion controls. Although sites with good buffers, lack of shoreline erosion, and gradual slope conditions tended to score lower they should still be monitored for future changes and, if necessary, improvement.

Figure 32. Lake Waukewan Parcel Scores

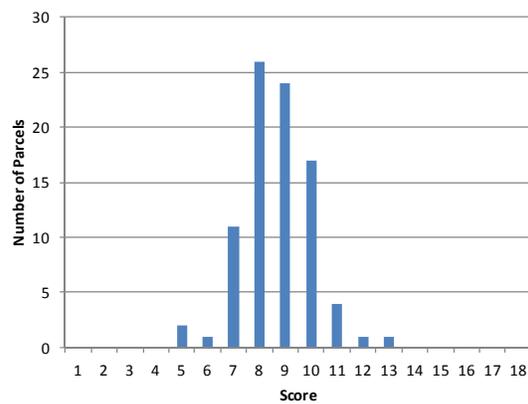
Figure 33. Lake Winona Parcel Scores

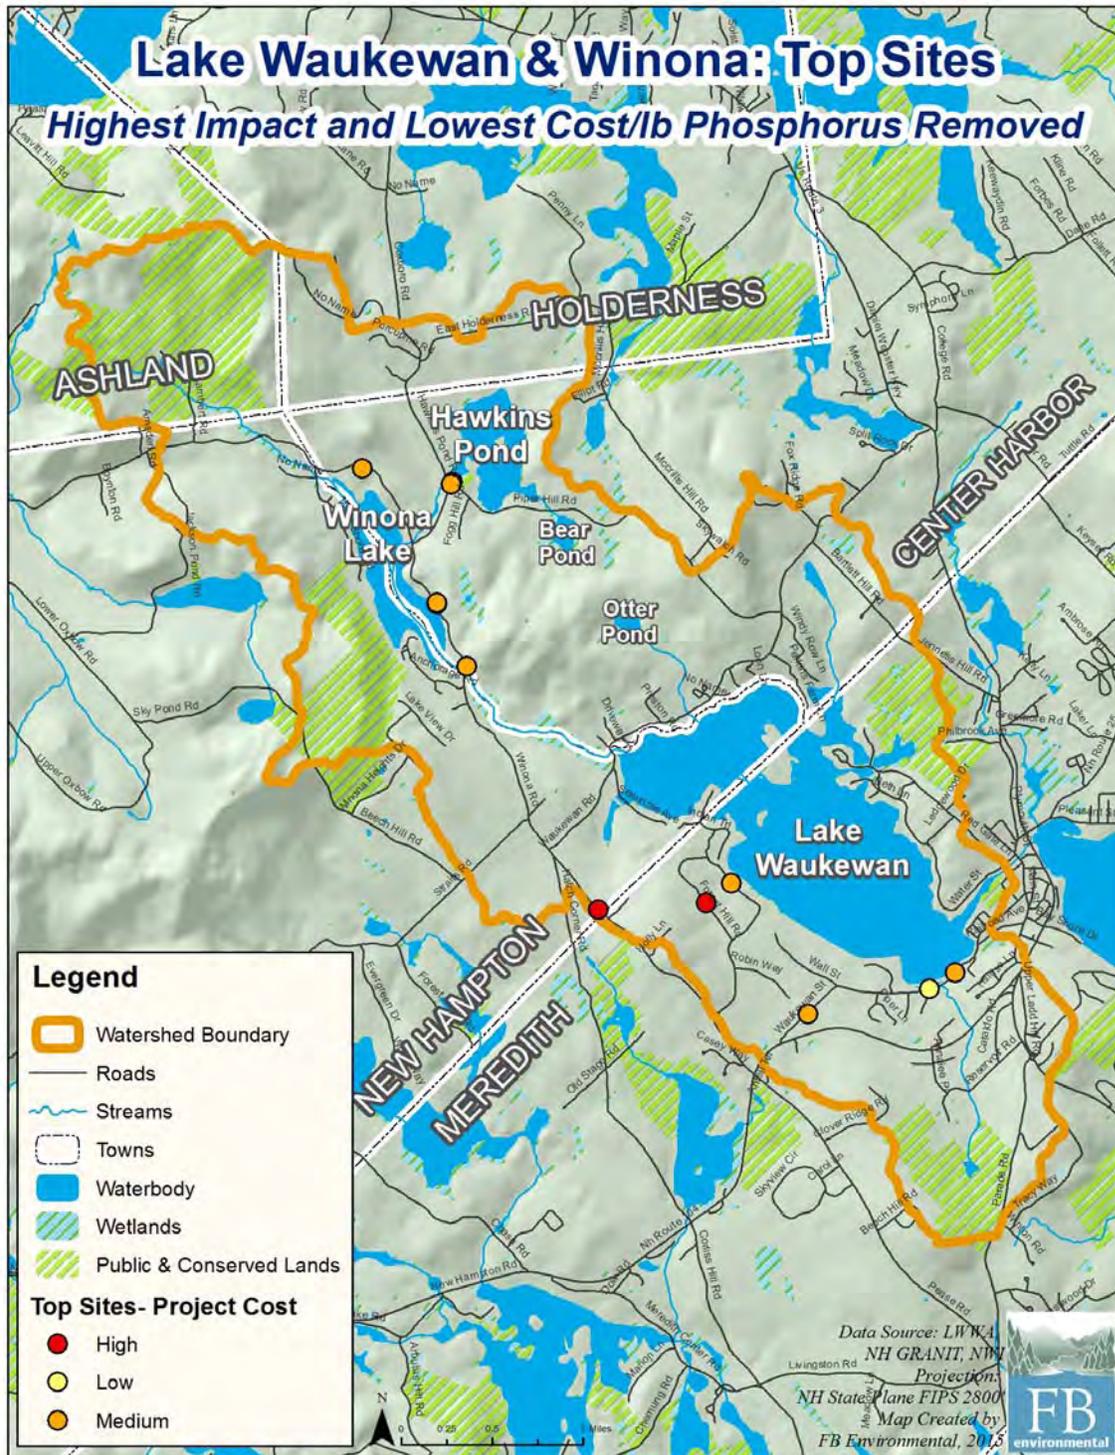
The **top six BMP** sites from the prioritized list of all identified survey sites for each of the Lake Waukewan and Lake Winona watersheds would remove **84.8 kg of phosphorus per year** from entering either Lake Waukewan or Winona (Table 24, Figure 34). This would account for **75 % of the total estimated P load** per year contributed by all surveyed problem areas. On average, the top 12 BMPs will have an estimated 10-year cost of \$874 per kilogram of phosphorus removed.

Figure 34. Map of top 12 BMP sites identified as having highest impact and lowest cost per pound of phosphorus removed.
