MOULTONBOROUGH BAY INLET

WATERSHED NONPOINT SOURCE SURVEY REPORT

PRODUCED FOR: Lake Winnepesaukee Association

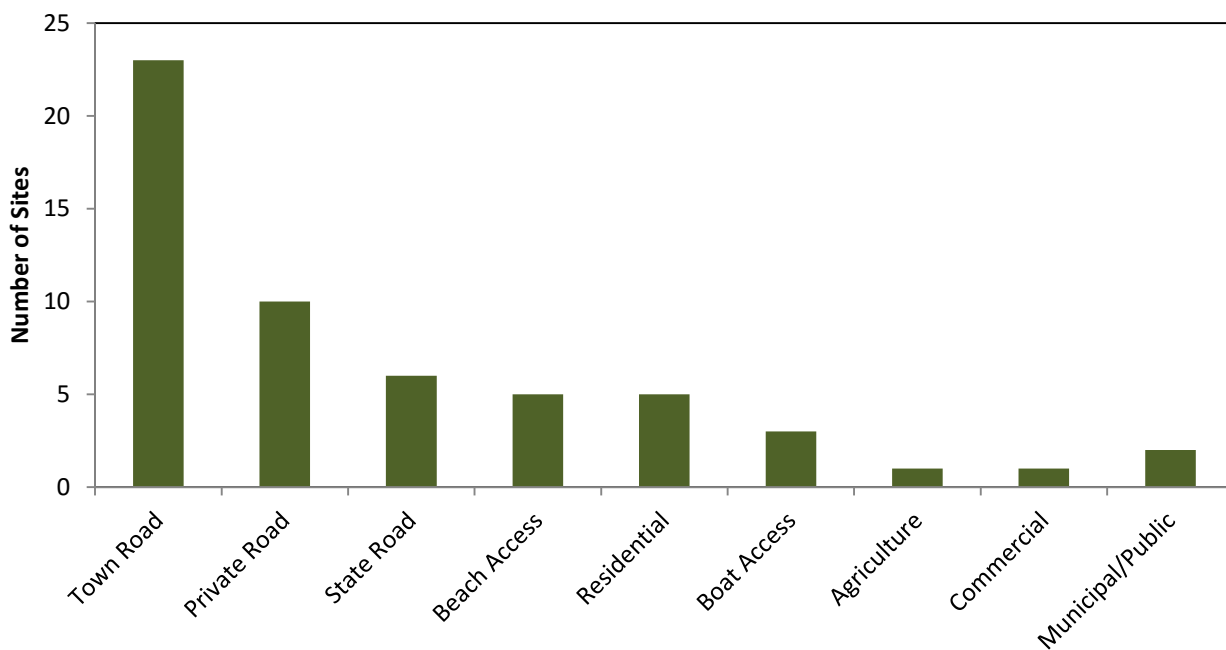
FIGURE 3. NUMBER OF SITES BY LANDUSE CATEGORY

Technical staff surveyed every public road in the watershed within the Town of Moultonborough and identified **56 sites** in the Moultonborough Bay Inlet watershed that are currently impacting or have the potential to impact water quality in the lake (Figure 3). Some key conclusions include:

- ✧ Twenty-three sites were located on town roads. These sites were often a result of eroding road shoulders and unstable culverts.
- ✧ Ten sites were located on private roads, concentrated in two developments on the northeast side of the Inlet. Landowners are encouraged to implement BMPs on these properties, primarily due to their proximity to the Inlet.
- ✧ Half of the identified sites were considered low impact. However, it is important to recognize that fixing multiple low impact sites can also have a significant impact on erosion control (Table 2).
- ✧ Fifty-five percent of sites were of medium cost to repair. These costs were then weighted by impact factor to identify the best way to cost-effectively improve erosion control. These numbers are available in Appendix A.

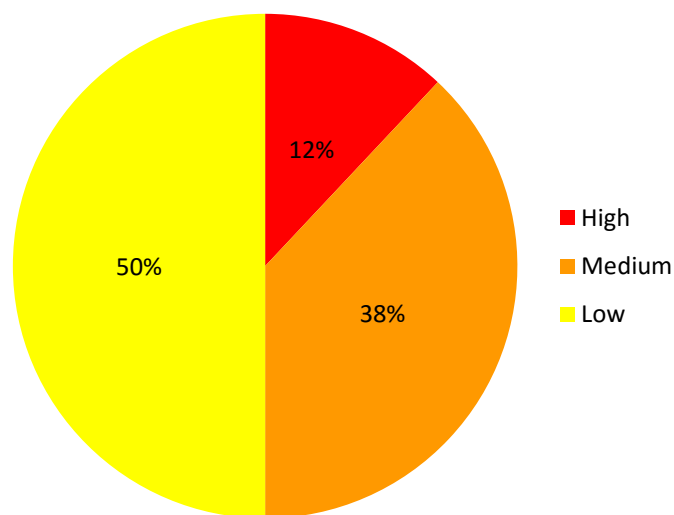
FIGURE 4. SITE IMPACT RATINGS

Each site was rated for its potential impact to waterbodies (Figure 4). “Low” impact sites are those with limited transport of soil off-site. “Medium” impact sites exhibit sediment transportation off-site, but the erosion does not reach high magnitude. “High” impact sites are those with large areas of significant erosion and direct flow to water.

Half of the surveyed sites were medium or high impact on water quality. **Impact** is based on slope, soil type, amount of eroding soil, buffer size, and proximity to water.

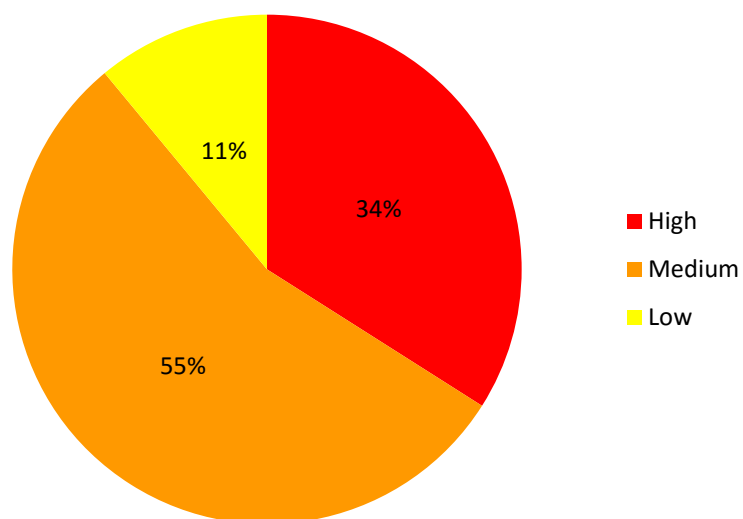
FIGURE 5. SITE COST RATINGS

Recommendations were made for fixing each NPS site, and the associated cost of labor and materials were estimated (Figure 5). Cost is an important factor in planning for restoration and effective BMP applications.

“Low” cost sites were estimated to cost less than \$500; “Medium” cost sites were estimated to cost between \$500 and \$2,500; “High” cost sites were estimated to cost more than \$2,500. Fifty-five percent of sites were rated medium cost.

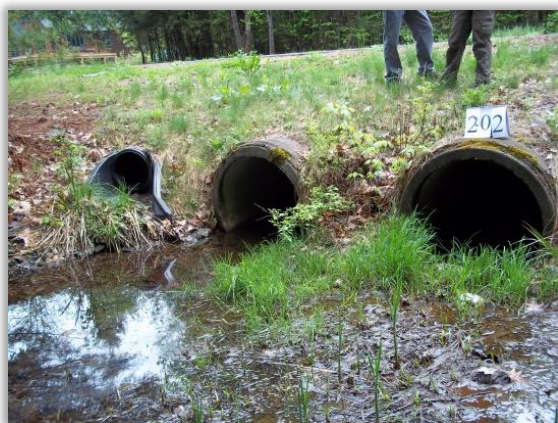
Problem: Undersized and Unstable Culverts

Solution: Enlarge and lengthen culverts to properly accommodate water flow. Armor the inlets and the outlets of culverts to reduce erosion. Install check dams to slow water flow.

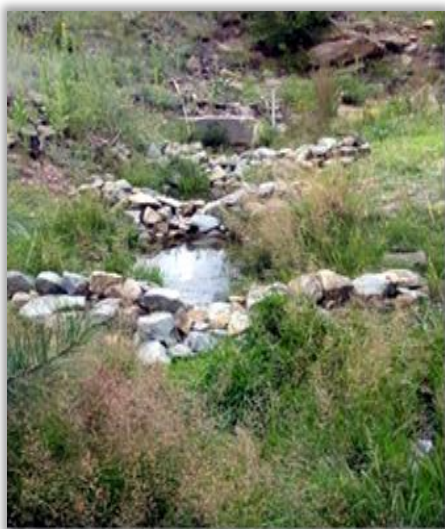
Check dams slow water from the ditch before entering the culvert.

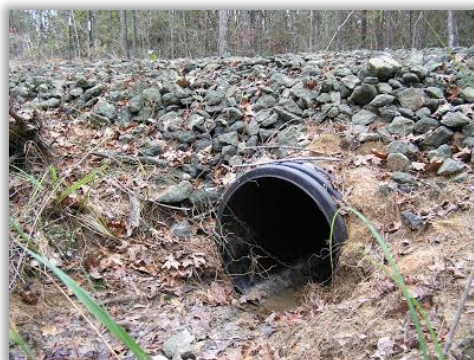
Armoring culverts reduces erosion of the road shoulder.

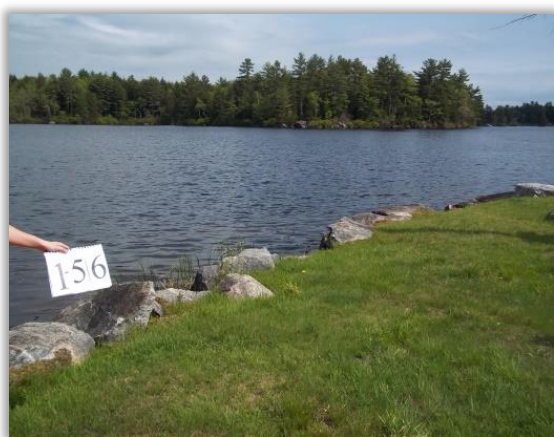
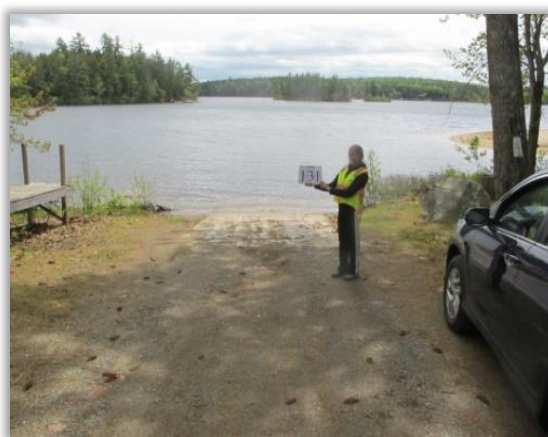
Problem: Shoreline Erosion

Solution: Apply recycled asphalt on boat launches and add vegetated buffers around shorelines.

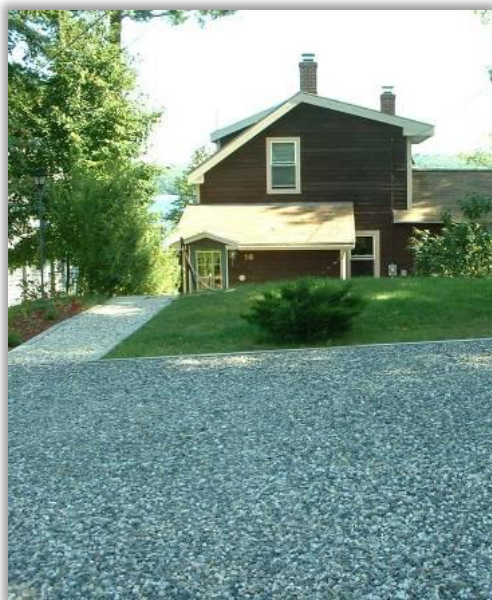
***Recycled asphalt reduces
surface erosion from
gravel roads.***

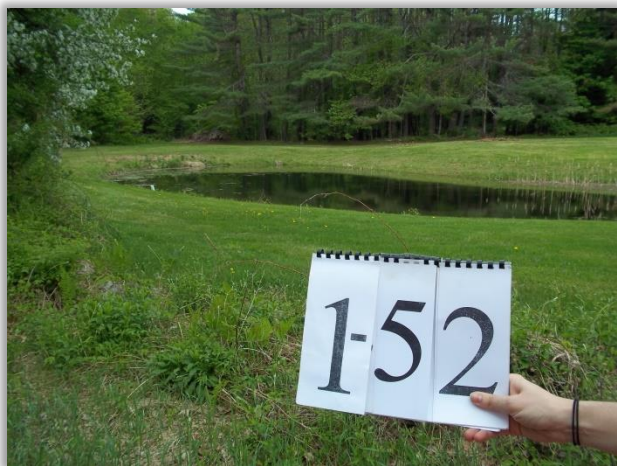
Problem: Lack of Vegetated Buffer

Leaving a “no-mow” zone around residential ponds reduces the amount of runoff in the stream. This runoff can include toxic pesticides or excess nutrients that pollute the stream.

Solution: Plant a vegetated buffer along streams and ponds. Increase the road shoulder where narrow gravel roads pass through wetlands.

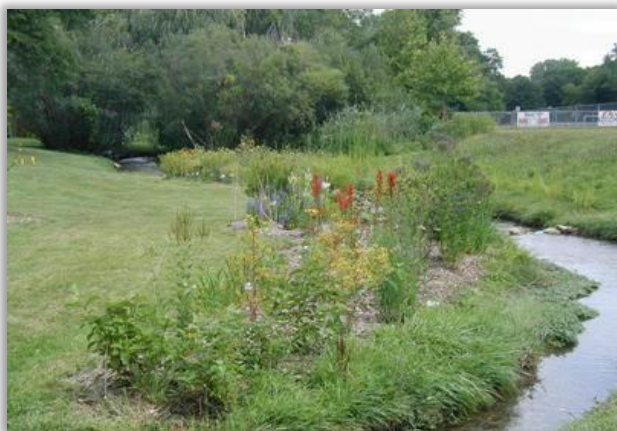
Planting vegetation along shorelines reduces erosion into the water.

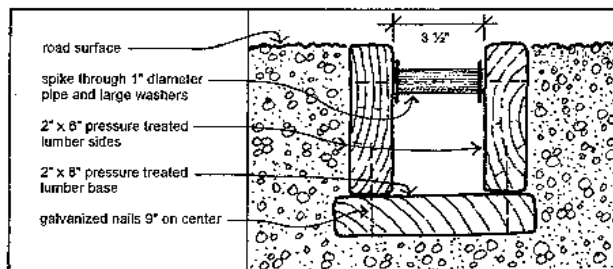
Rubber Razor Blade or Open Top Culvert: Use a rubber razor structure in a gravel driveway or camp road. It can be plowed over only if the plow operator is aware of its presence and lifts the plow blade slightly. Use an open top culvert (shown at right) in a gravel driveway or camp road that does not get plowed in the winter. Place at a 30 degree angle to the road edge and direct the outlet toward a stable vegetated area.

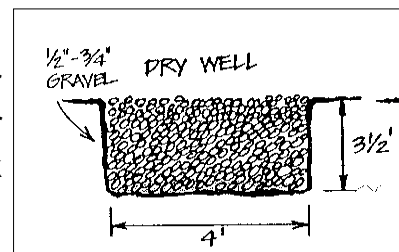
Drywell: Use a drywell to collect runoff from roof gutter downspouts. Drywells can be covered with sod or left exposed for easy access and cleanout. Drywells and infiltration trenches work best in sandy or gravelly soils.
