# **Gunstock Brook Watershed Stream Geomorphic Assessment**

**Gilford, New Hampshire  
July 9, 2012**

Prepared by:  
Bear Creek Environmental, LLC  
297 East Bear Swamp Road  
Middlesex, Vermont 05602

Prepared under contract to:  
Belknap County Conservation District  
2 Airport Road, Unit #1  
Gilford, NH 03249

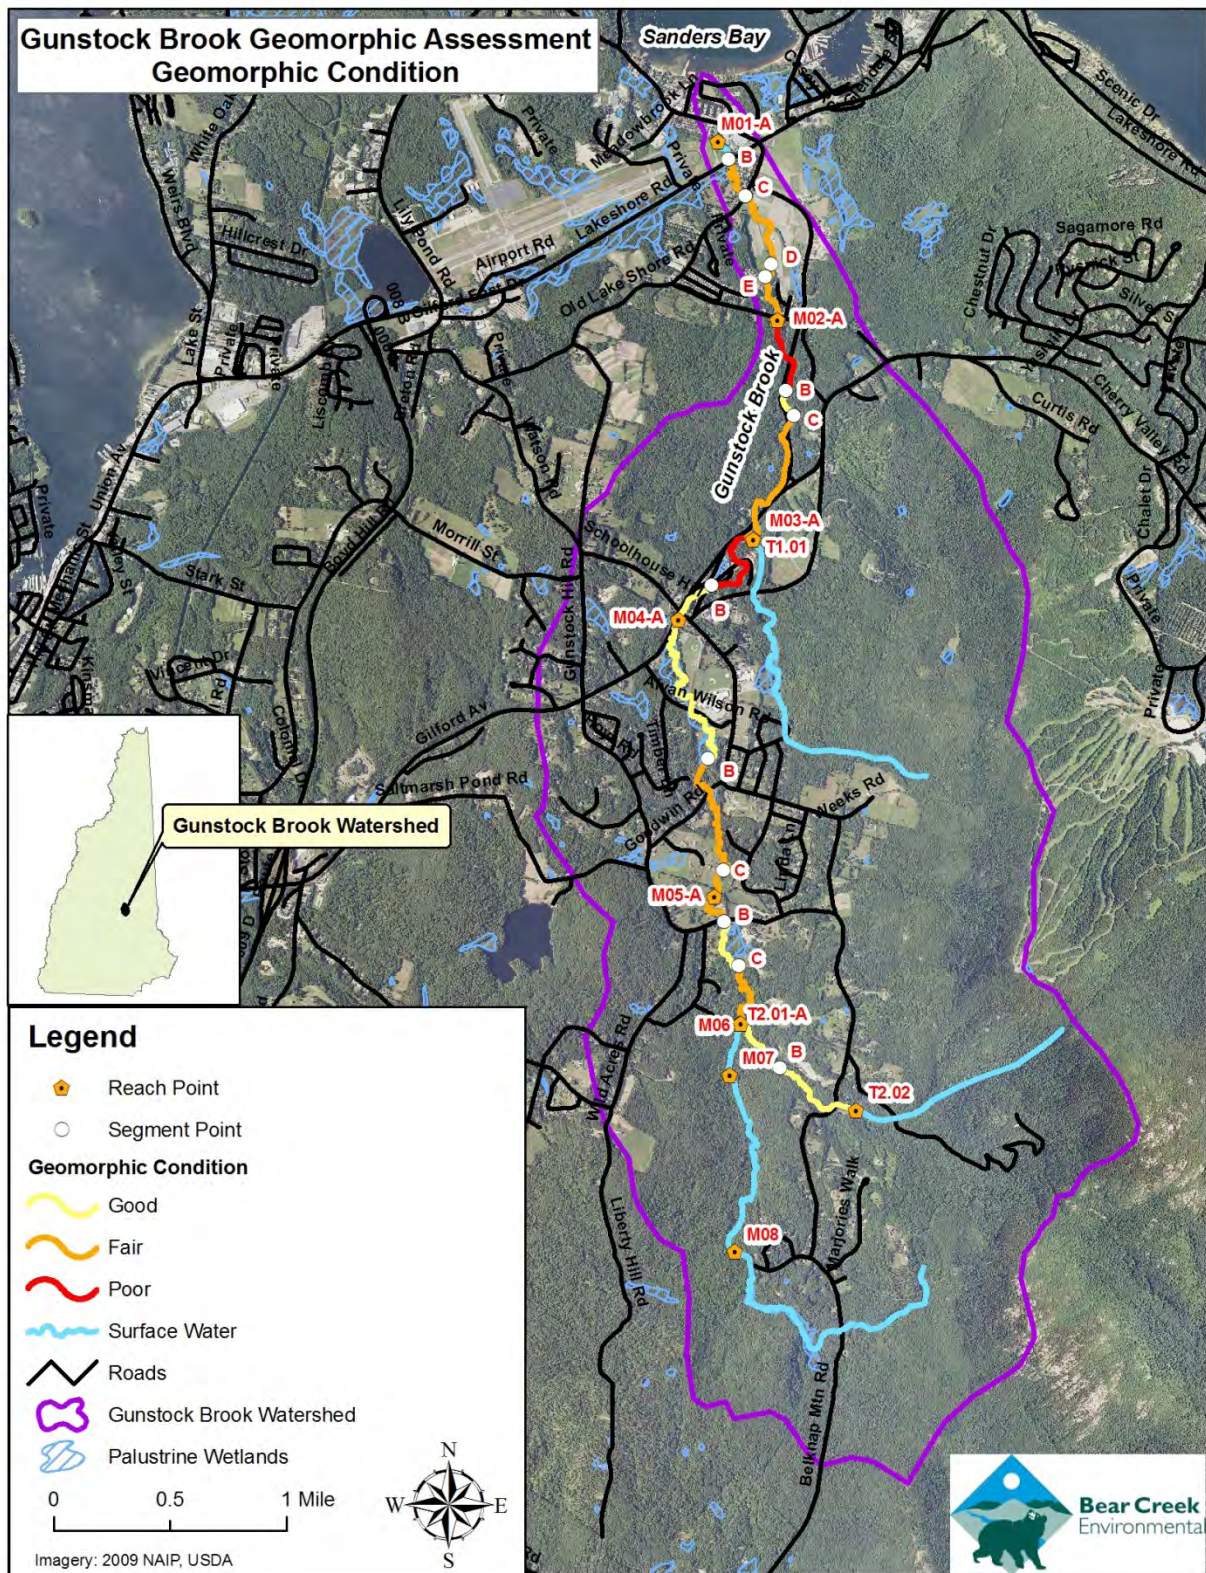
Four segments along the main stem of Gunstock Brook are in “good” geomorphic condition (M02-B, M03-B, M04-A, and M05-B). In addition, the most downstream reach on the major tributary to Gunstock Brook (T2.01) is in “good” geomorphic condition. Two of the Gunstock Brook segments in “good” condition are located in higher gradient, more confined sections with step-pool bedform and cobble dominated substrate. The other two segments in “good” condition are surrounded by wetland, have healthy buffers, and minimal encroachments. All of the remaining segments except two, which have a “poor” condition (M02-A and M03-A), are in “fair” geomorphic condition. Segment M02-A, located upstream of the Henderson Road crossing is impacted by floodplain encroachments from Intervale Road and a undersized and poorly aligned bridge crossing at Intervale Road. The poor geomorphic condition of segment M03-A is related to extensive straightening of the channel and floodplain encroachment from development near the Gilford Town offices. In the areas that are in “poor” or “fair” condition, significant instream modifications and floodplain encroachment is common leading to an increase in stream power in the channel and a loss of functioning floodplains.

**Figure 5.1. Phase 2 Geomorphic Condition of the Gunstock Brook Watershed**

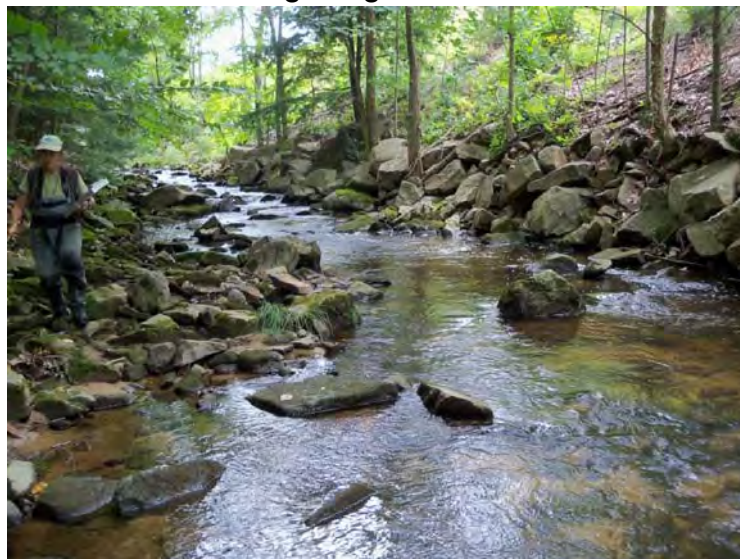
**Figure 8.21. Natural cobble dominated “Fb” channel in M03-B.**

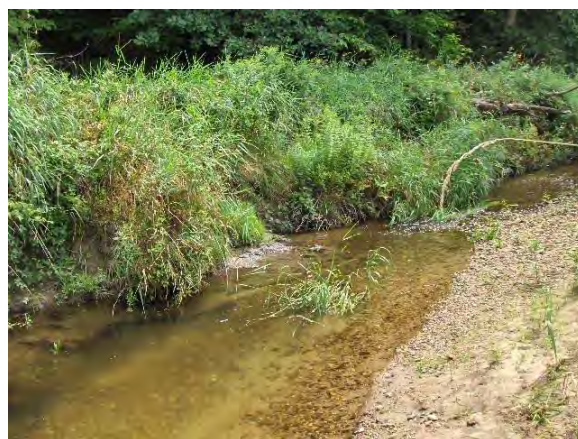
**Figure 8.25. Typical wetland channel in M04-A.**

Based on the Phase 2 assessment, both the geomorphic and habitat conditions of segment M04-A are “good”. The stream type is a gravel dominated “C” stream which has not incised. Segment M0-4A is undergoing minor aggradation with some diagonal and point bars and limited planform change with the presence of an island. Abundant large woody debris, coarse particulate organic matter and deep pools that are providing suitable water depths for fish and amphibians has contributed to the “good” habitat condition. Alders are the dominant vegetation on the banks. Given the prime riparian condition and wetland habitat, a 1,890 foot length of Segment M04-A is recommended for conservation to protect it from future impacts and to maintain the function of the wetland it flows through (Project #14).

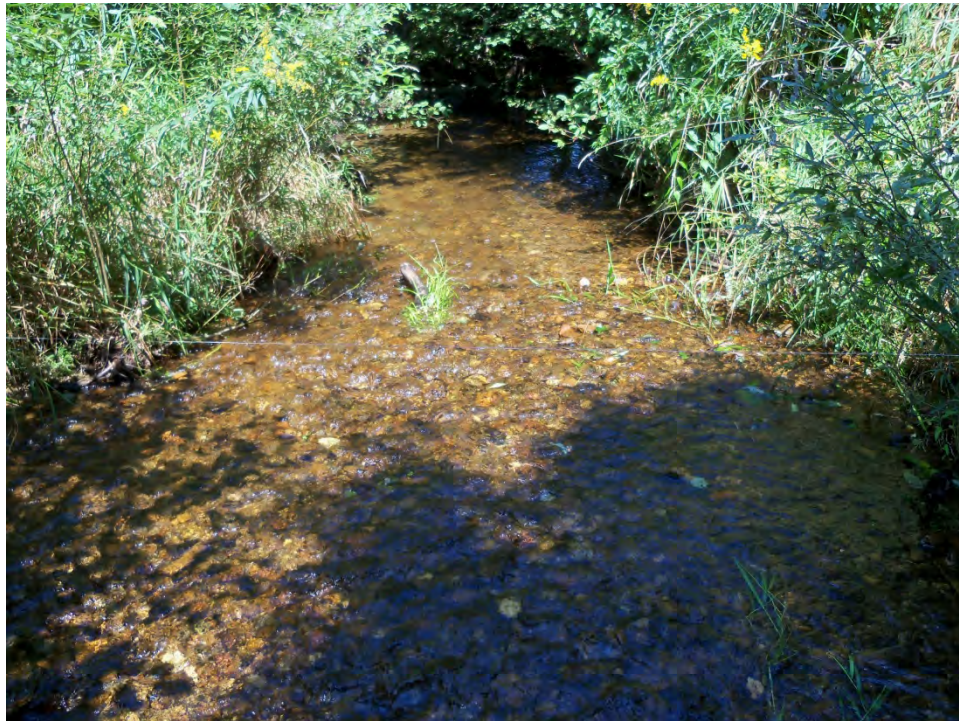
The banks are well vegetated (Figure 8.35) along most of the segment except where there is no vegetated buffer by one of the bridges and the lawn on the western side. One major impact in M05-A is that it has been straightened at the downstream end for approximately one third of its length. The channel alteration most likely led to the major incision observed in M05-A. The channel has not yet widened. The stream type is a gravel dominated “C” stream with riffle-pool bedform. There is minor aggradation in the segment as observed through some steep riffles, diagonal bars, point bars, side bars, and mid-channel bars. Planform has changed somewhat due to the aggradation, but not as pronounced as in reaches upstream from here.

Both the geomorphic and habitat condition resulted in a “fair” score. The “fair” geomorphic condition was primarily due to the channel incision and channel alteration. Compromised riparian area on the eastern side due to the hay field, lack of abundant woody debris, and loss of floodplain access contributed to the “fair” habitat condition.

**Figure 8.35. Well vegetated banks in M05-A.**

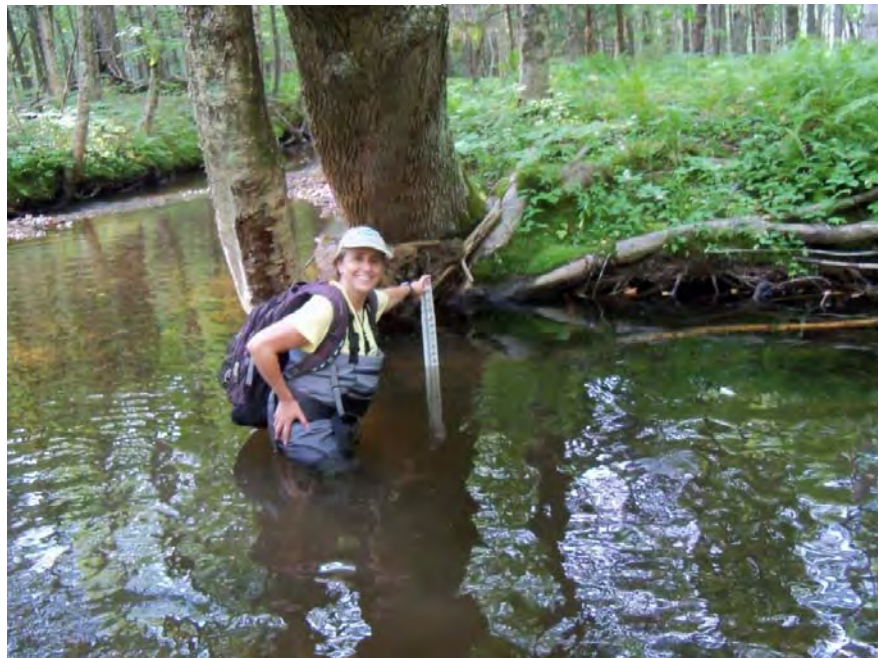
The RGA condition scored in the “fair” category due to the major aggradation and resultant planform adjustment. There was no incision in this Segment M05-C and the channel therefore has good access to its floodplain. The RHA scored in the “good” category mostly due to the nice undercut banks and pools (Figure 8.39) and well vegetated stream banks and riparian corridor. Given the high quality buffer and corridor conditions and habitat, it is recommended that Segments M05-B and M05-C be considered for conservation (Project #18). These two segments serve as key flood and sediment attenuation sections of Gunstock Brook and development within the corridor would jeopardize the ability for them to continue to provide flood and sediment retention.

**Figure 8.39. Deep pool and nice undercut bank in M05-C.**

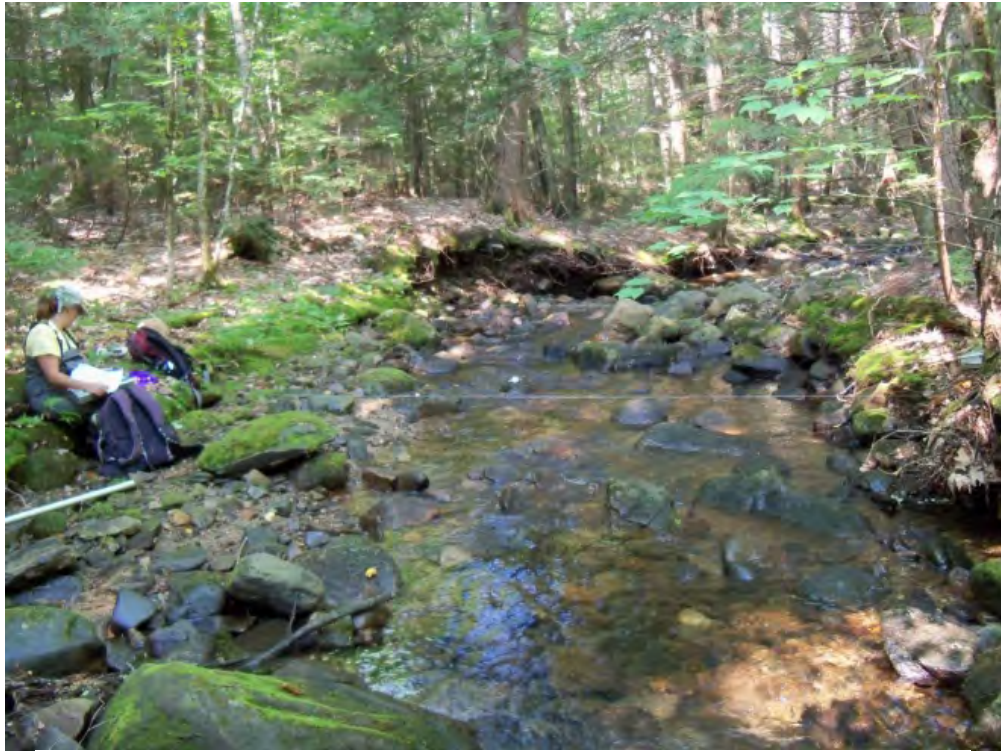
Segment T2.01-B begins where the valley becomes narrower and continues approximately ½ mile until 450 feet upstream of Belknap Mountain Road. Like T2.01-A, the banks and buffers are well forested in Segment T2.01-B. There has been no incision based on the cross section measured in this segment (Figure 8.42). Some banks are higher but this is more a function of natural floodplain variability than incision. There is very little erosion indicating that the segment is not widening. The stream type is a gravel dominated “C” channel with a slope of a “B” channel that has a dominant bedform of riffle-pool with a subdominant bedform of step-pool (upstream of Belknap Mountain Road). The channel is in the first stage of the channel evolution model, indicating it stable condition. All geomorphic processes were scored in the “good” or “reference” category. The lack of channel alteration, high quality banks and buffers, minor erosion and channel migration is indicative of the “good” geomorphic condition. The habitat condition also scored as “good” as a result of abundant pools, good hydrologic characteristics, nice undercut banks (Figure 8.43), and high quality banks and buffers.

**Figure 8.42. Cross section in T2.01-B showing good floodplain access.**

Conservation of reach T2.01 is recommended to provide continued flood and sediment attenuation (Project #20). Flood and sediment attenuation is important to prevent further transport of sediment to Gunstock Brook.

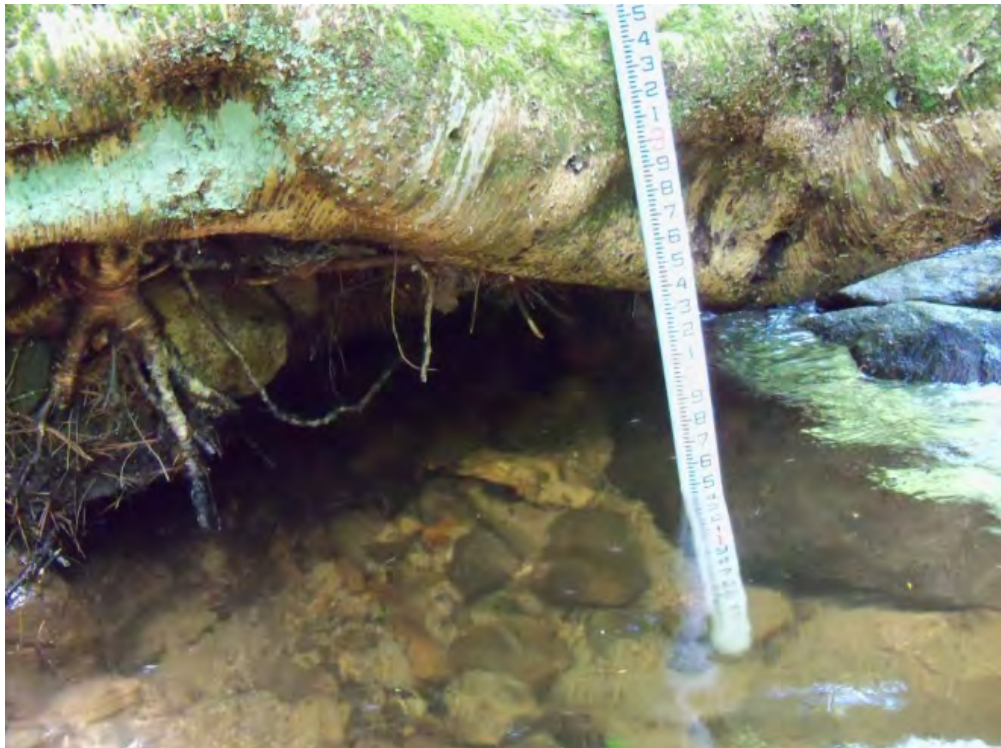
**Figure 8.43. Nice undercut in T2.01-B providing cover for aquatic species.**
